STATE COMMISSION ON AIRCRAFT ACCIDENTS INVESTIGATION

PRELIMINARY REPORT

Occurrence No: 982/14

aircraft: airplane, Bombardier CRJ-700, D-ACPJ

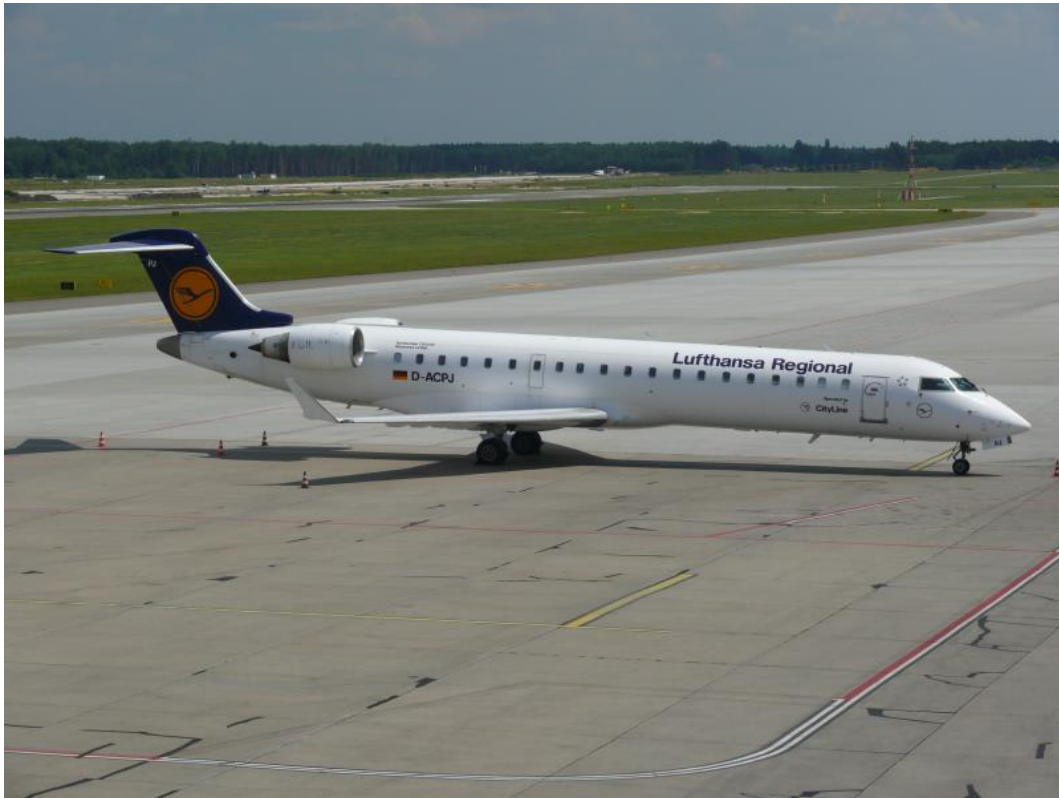
Photo 1. Bombardier CRJ-700 airplane on the apron of Katowice-Pyrzowice aerodrome.

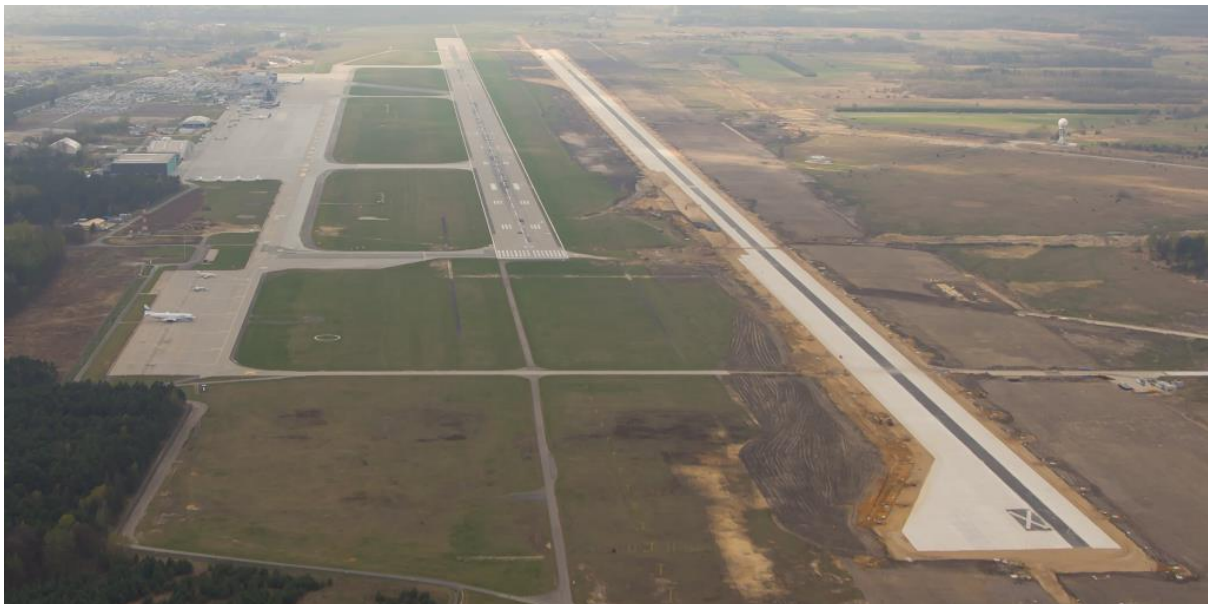
Photo 2. Katowice-Pyrzowice aerodrome (11 April, 2014), direction 27 – the runway under construction on the right side. [EPKT photo]. On the day of the occurrence the black strip on the runway surface did not exist anymore.

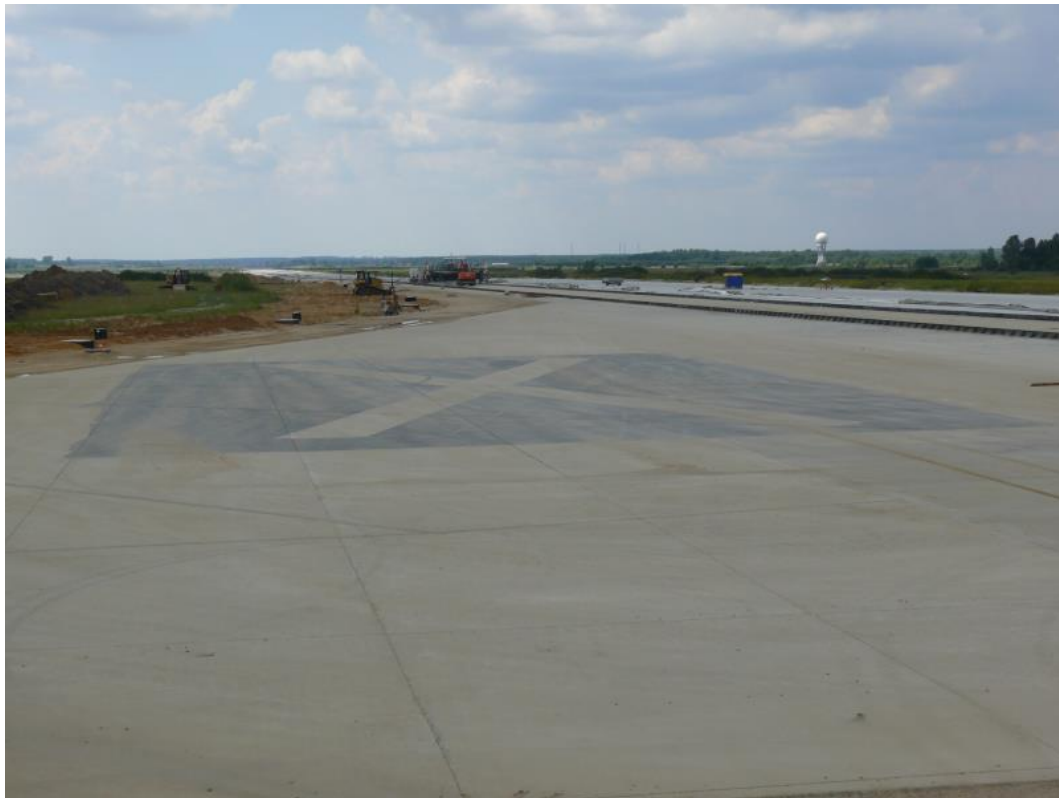
Photo 3. Marking of the closed runway under construction in the threshold 27 area.

Due to termination of the works involving construction of the runway foundation which was made of cement concrete and with a view to avoid misinterpretation of the new pavement as an active runway, the airport management ordered the contractor to produce and maintain a horizontal markings showing a closed runway at each end of the runway under construction. These markings should be white on a contrasting background (i.e. with a black outline) and have the shape and dimensions in accordance with ICAO Annex 14 “Aerodrome Design and Operations”.

1. Improve and maintain in the proper condition the horizontal markings informing about closure of the runway under construction.
2. Consider use of warning lights on the runway under construction, especially in the conditions of limited visibility.
3. Send to all the operators using the Katowice-Pyrzowice airport a reminder of the ongoing construction works.

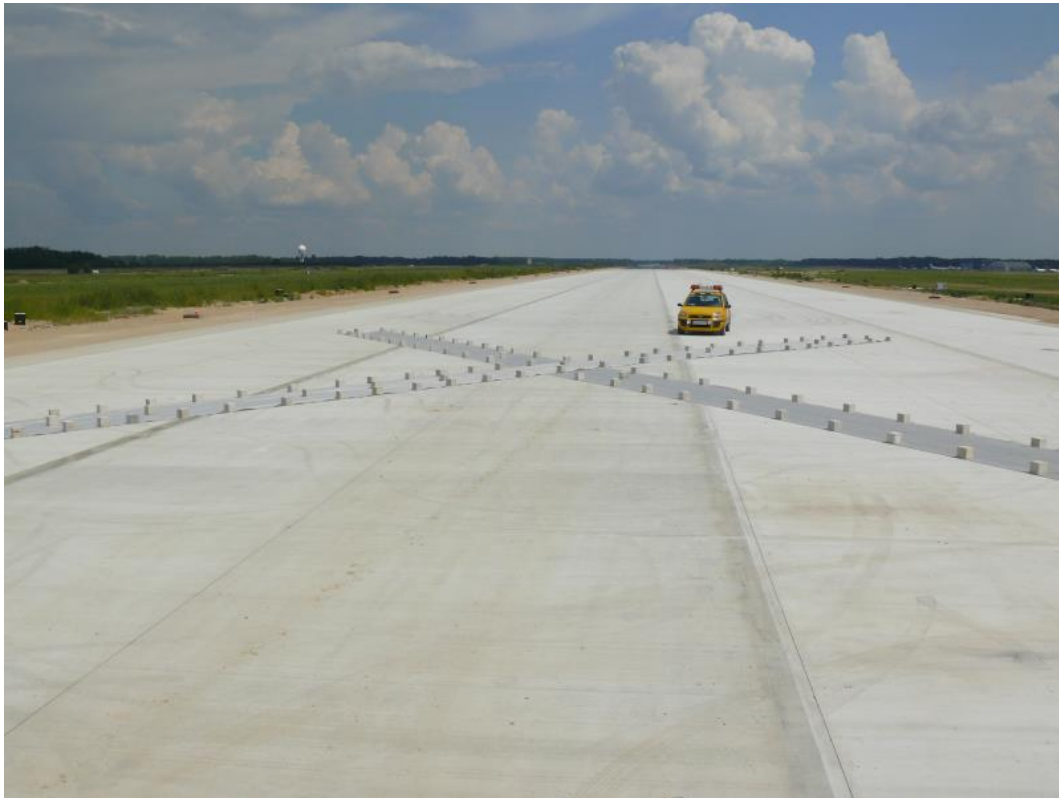
Photo 4. Marking of the closed runway under construction in the threshold 09 area.

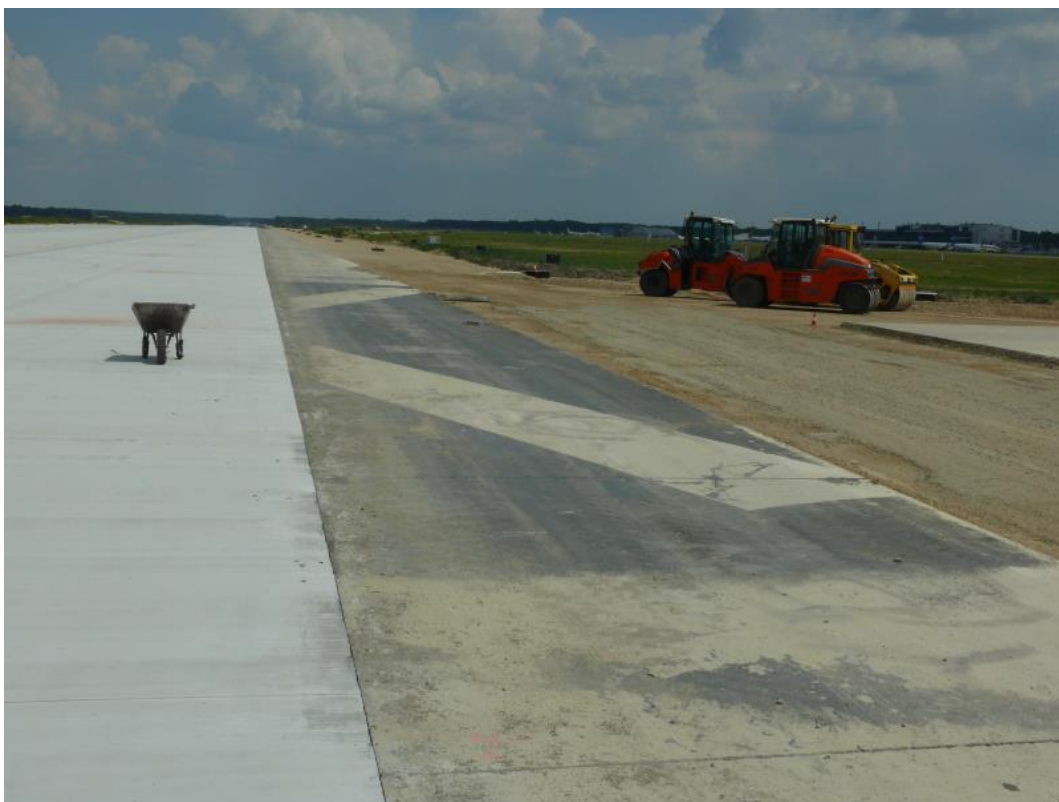
Photo 5. Marking of the closed runway under construction in the threshold 09 area partially covered with concrete.

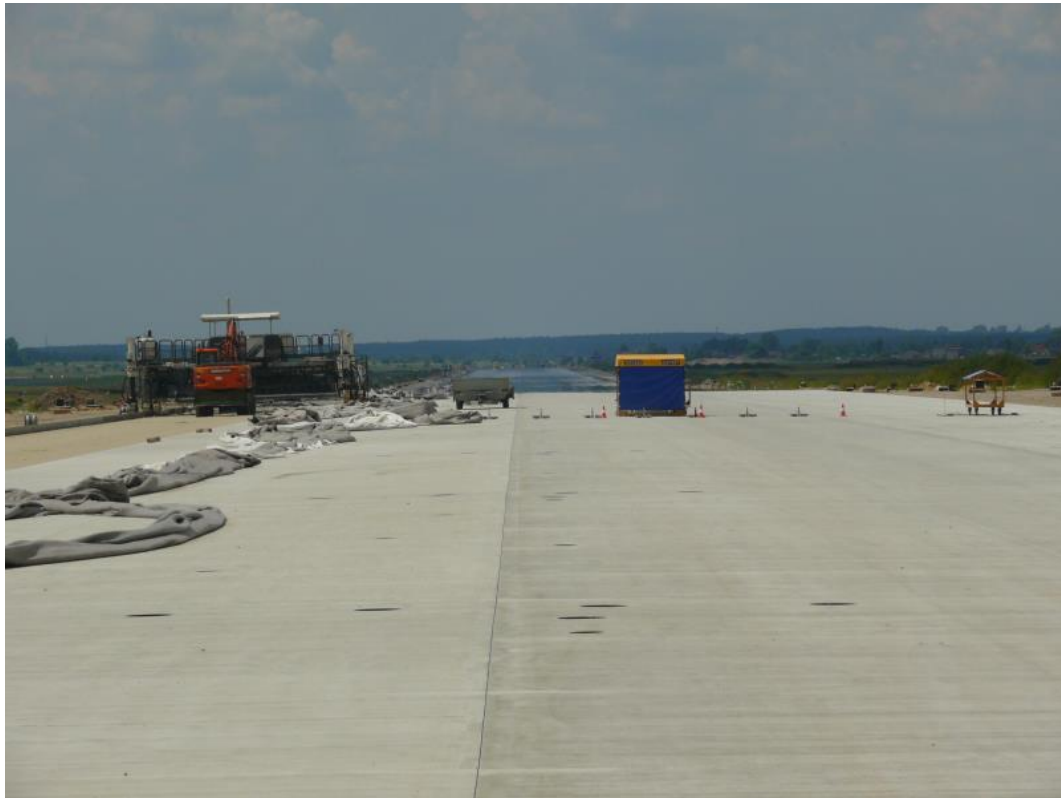
Photo 4. Construction machinery on the runway under construction (~260 m from the beginning of the runway 27 surface).

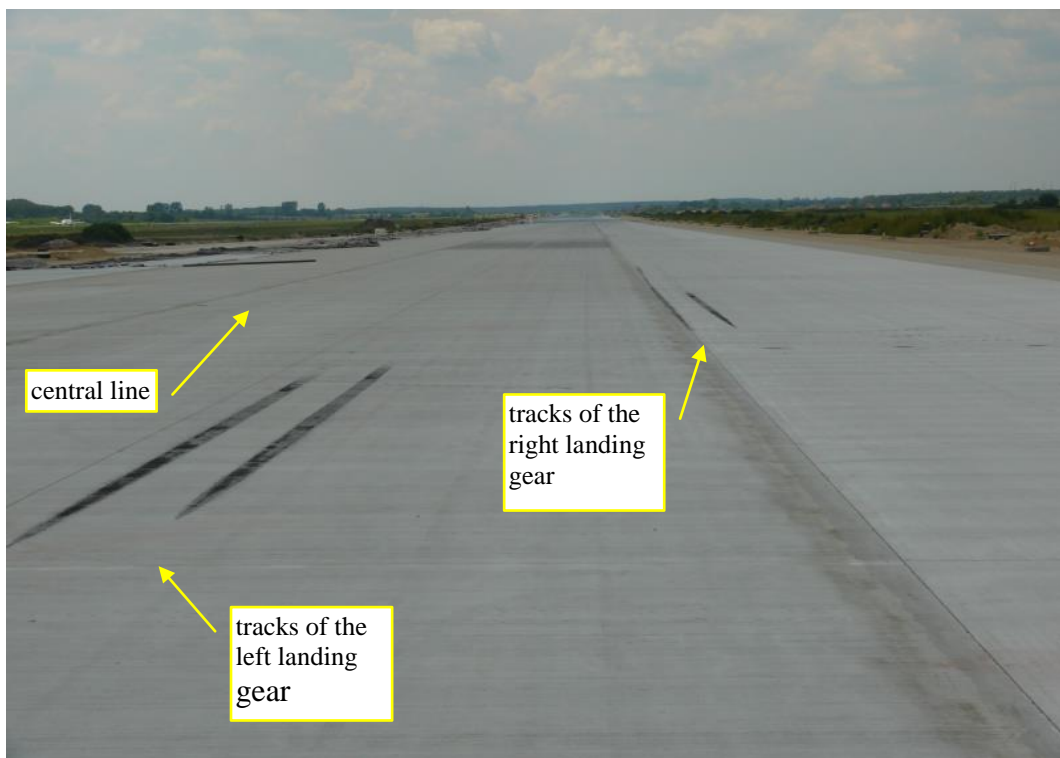
Photo 5. Touchdown tracks of the Bombardier CRJ-700 (~870 m from the beginning of the runway 27 surface).

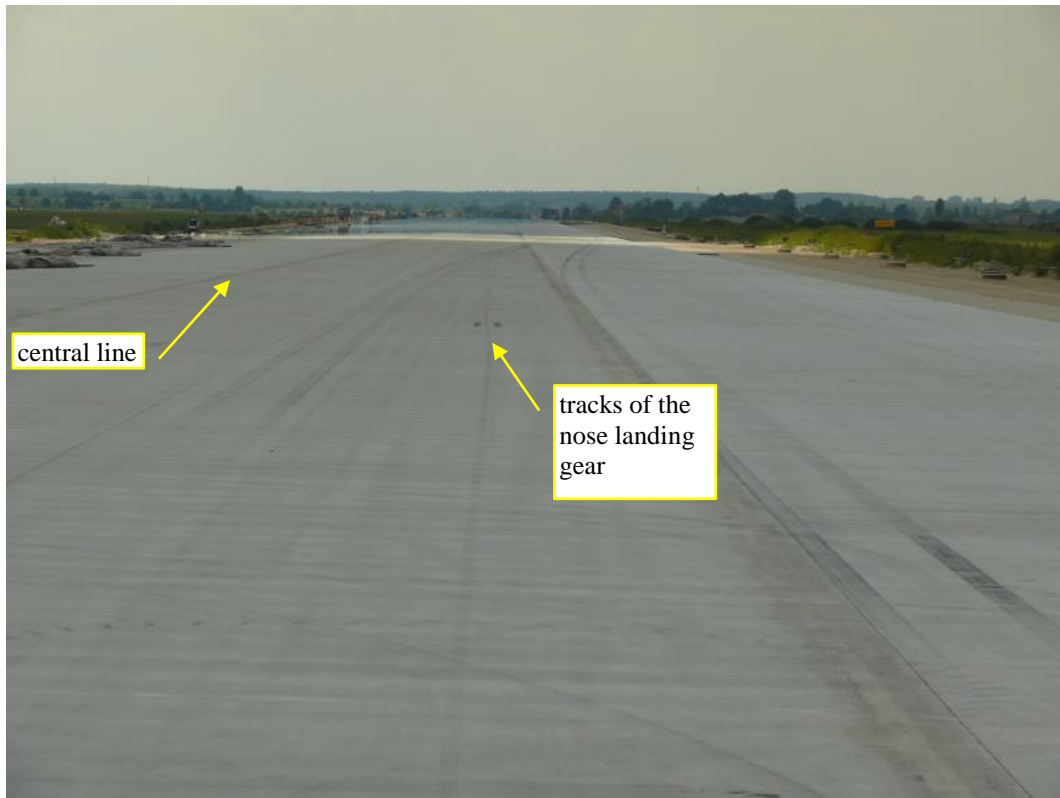
Photo 8. Touchdown tracks of the nose landing gear (~1130 m from the beginning of the runway 27 surface) and a turn at the beginning of the landing roll.

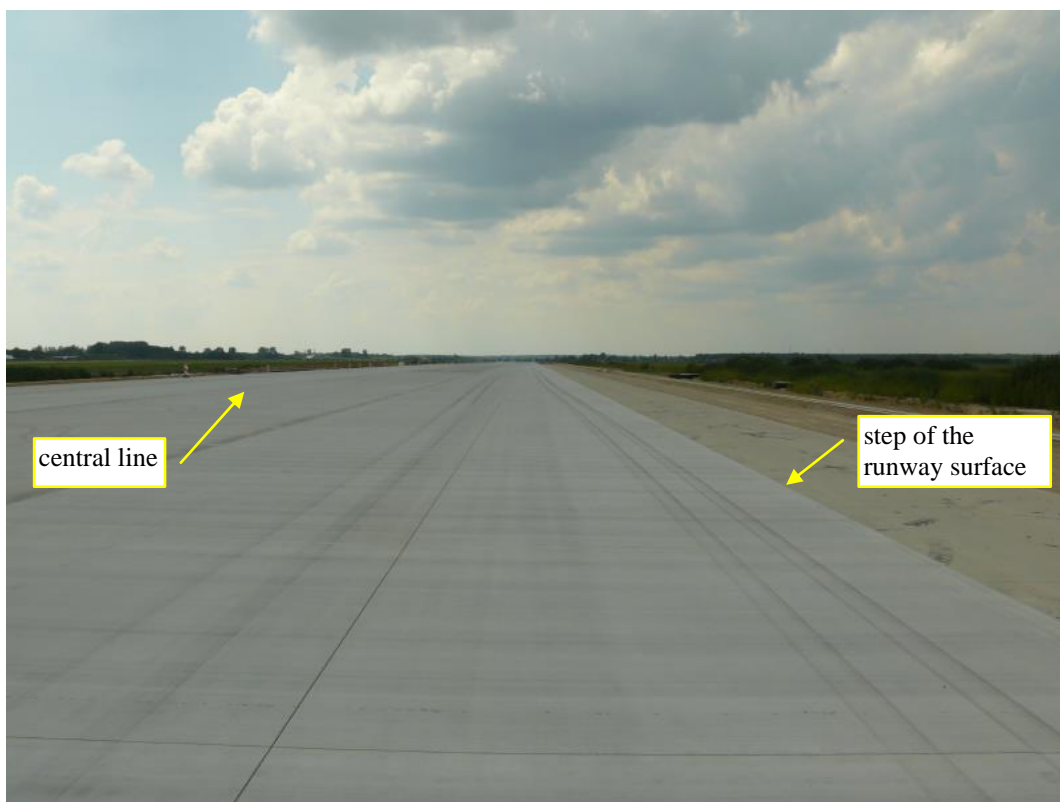
Photo 6. Tracks of the closest proximity between the airplane RMLG and the step of the newly constructed runway surface (1 m distance).

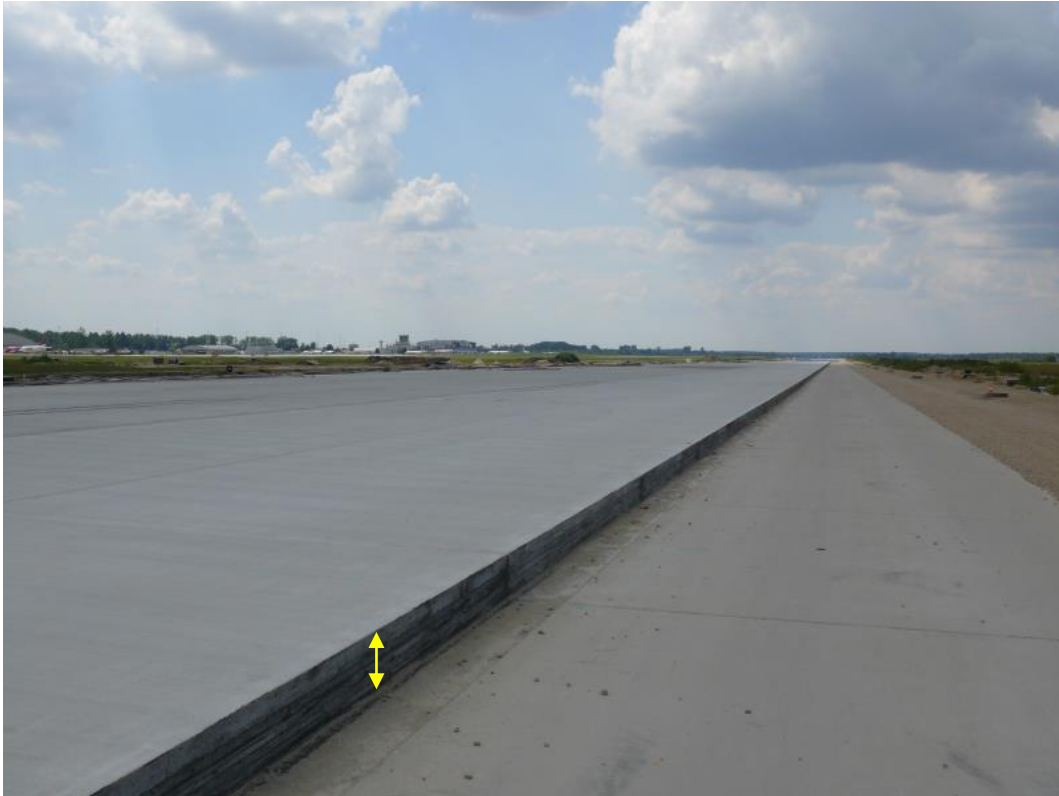
Photo 7. Step of the surface of the newly constructed runway (30 cm high – yellow arrow), right side.

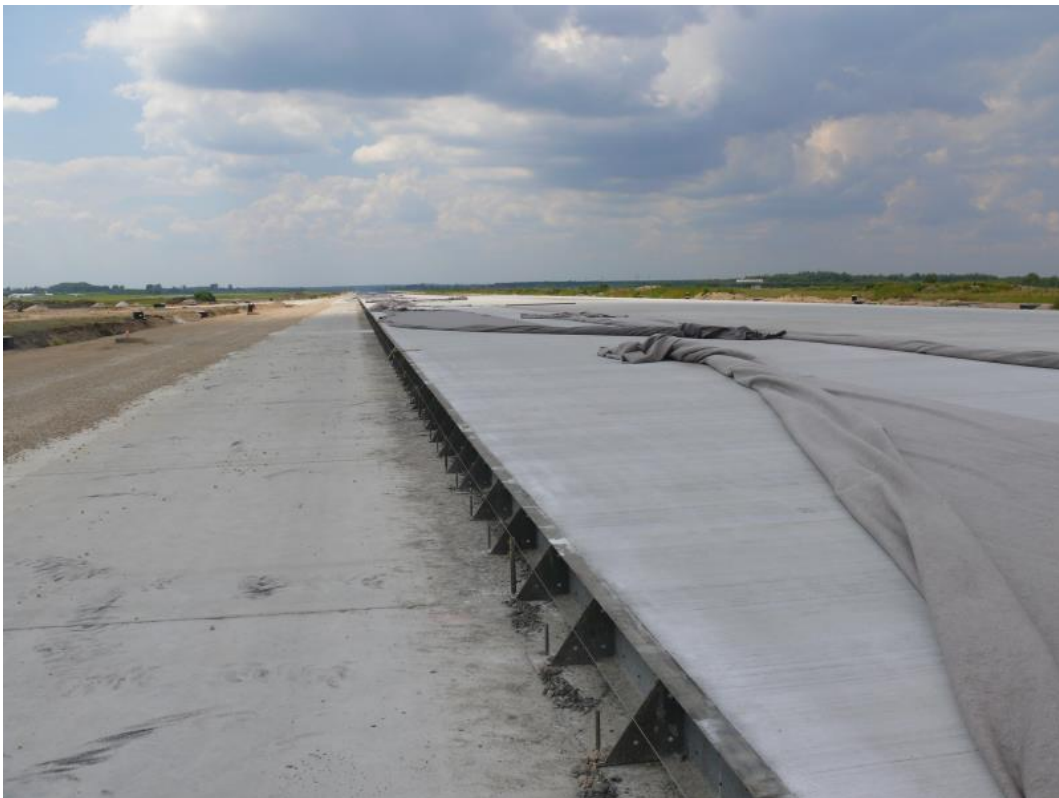
Photo 8. Structure forming/bounding the surface of the newly constructed runway (left side).

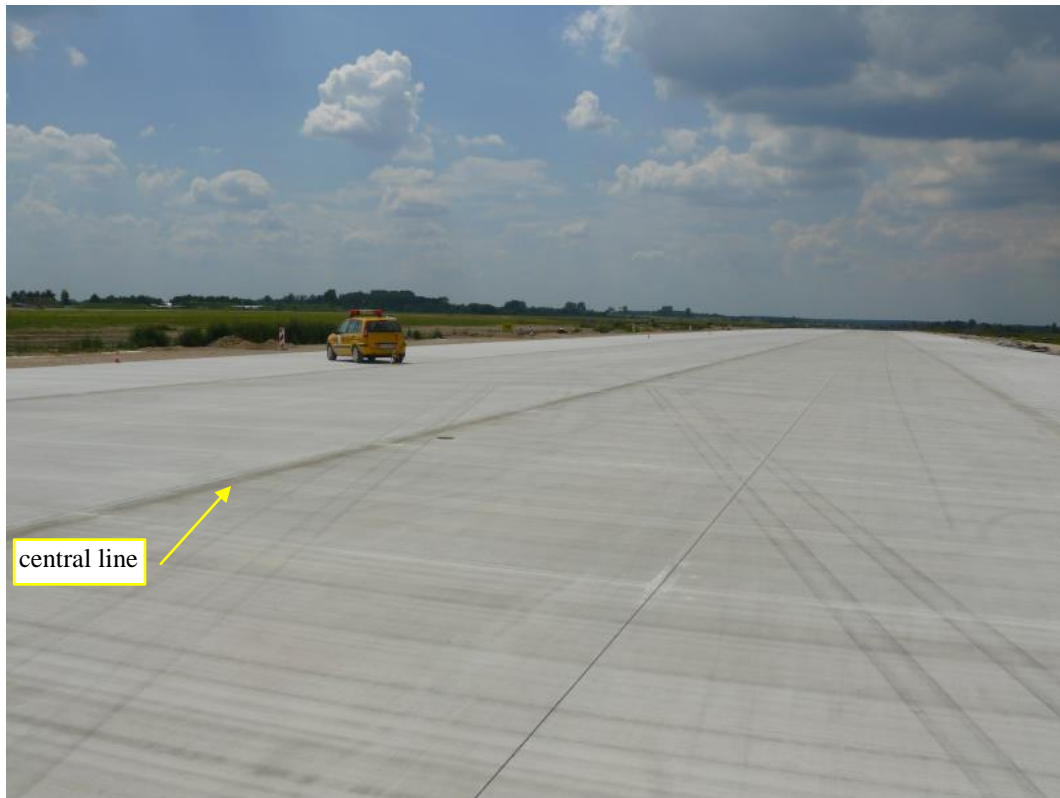
Photo 9. Tracks of the airplane stop on the runway under construction (~2700 m from the beginning of the runway 27 surface).

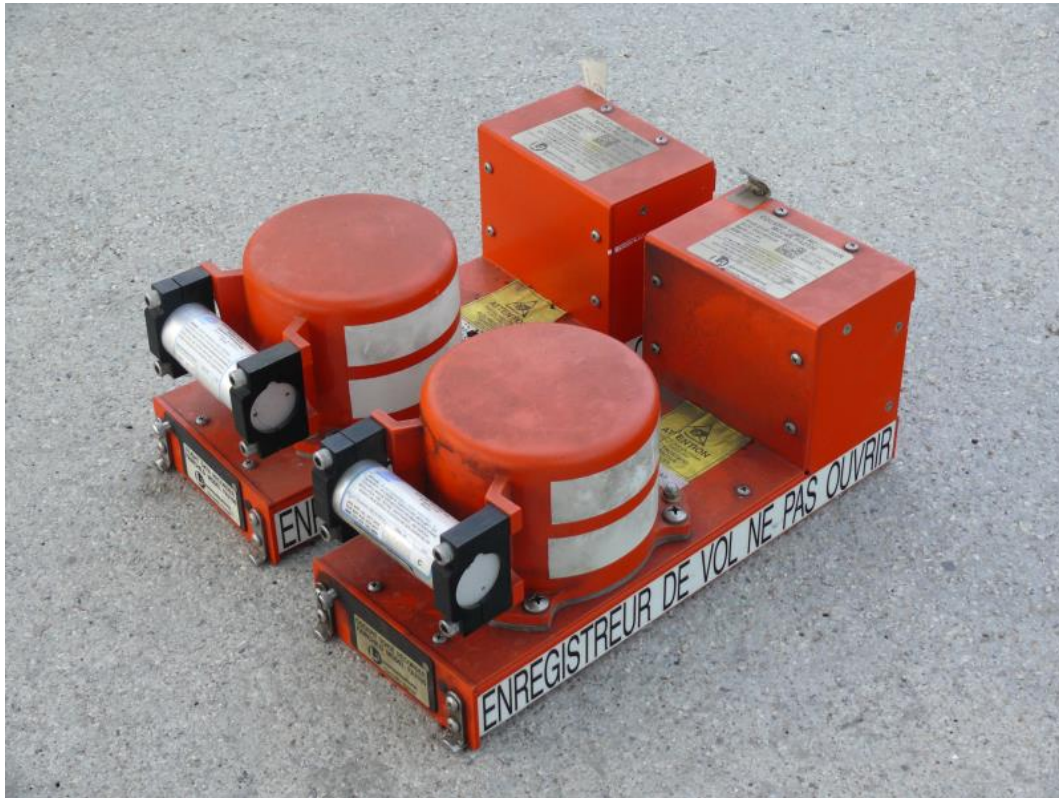
Upon arrival of the operator maintenance personnel, an inspection of the airplane was carried out – no damage was found. Flight Data Recorder (FDR) and Cockpit Voice Recorder (CVR) were protected. Recordings of the recorders will be used in the further investigation of this air occurrence.

Photo 10. FDR and CVR from the Bombardier CRJ-700 airplane.

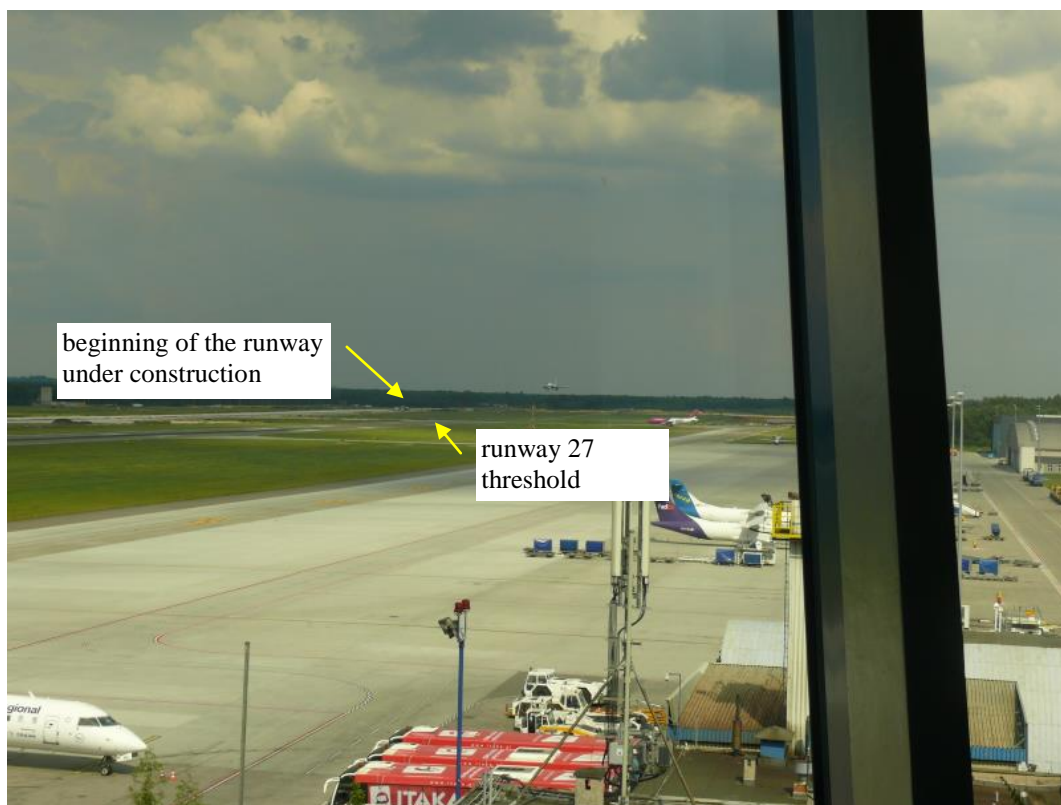
Photo 11. View on a landing airplane from EPKT Tower.

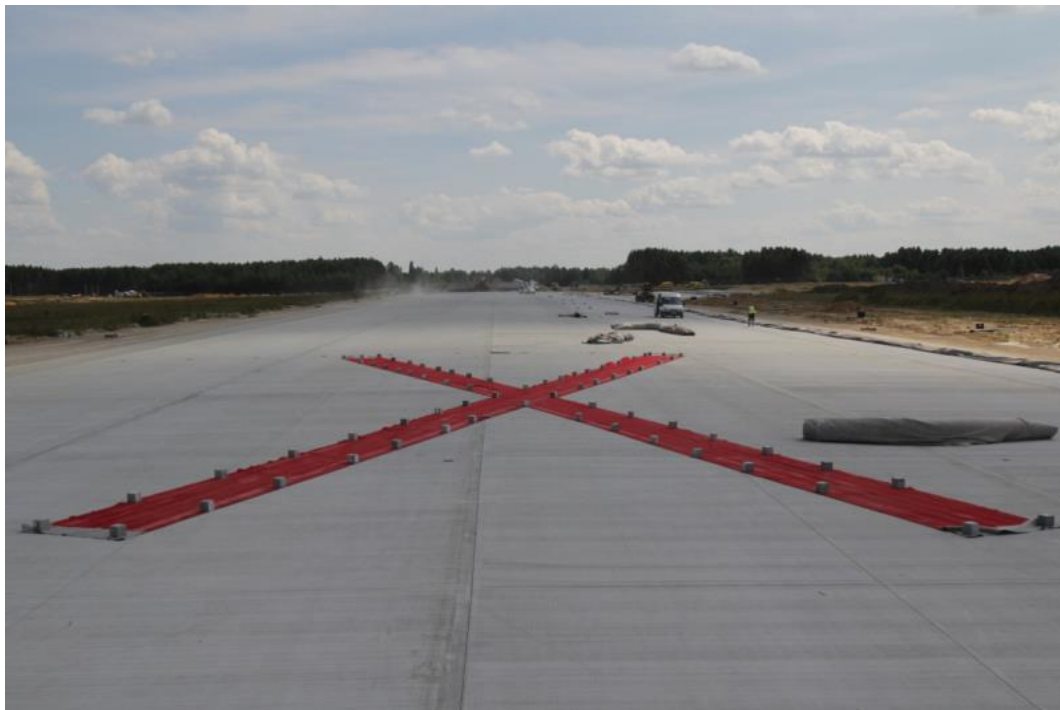
Photo 12. Marking of the closed runway under construction in the area of the threshold 27.

“Place additional marking of a closed runway (red cross) on the runway under construction. Crosses in this color are to be placed close to both thresholds and in the middle of the runway”.

The airport management has introduced the correct markings of the closed runway under construction.

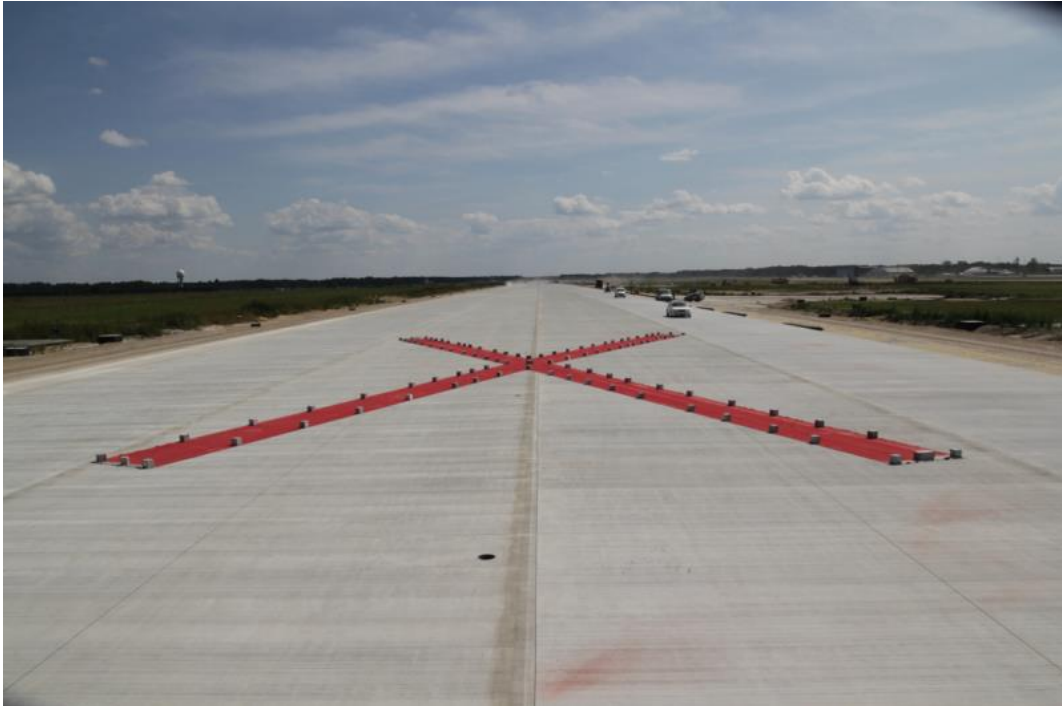
Photo 16. Marking of the closed runway under construction in the area of the threshold 09.

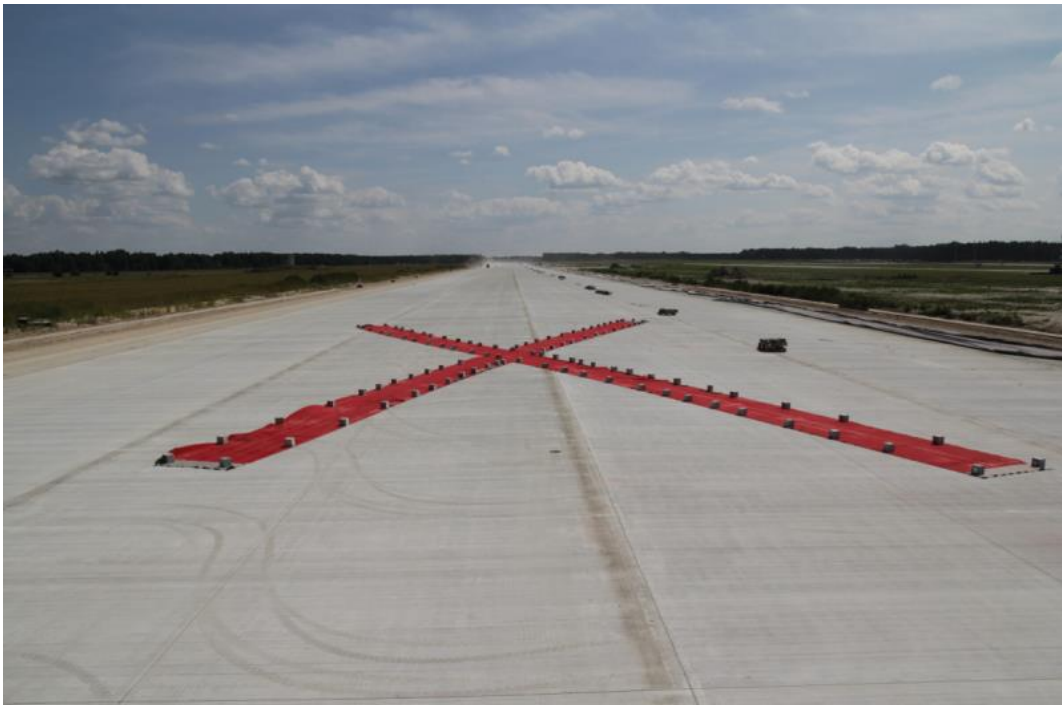
Photo 17. Marking in the middle of the closed runway under construction.

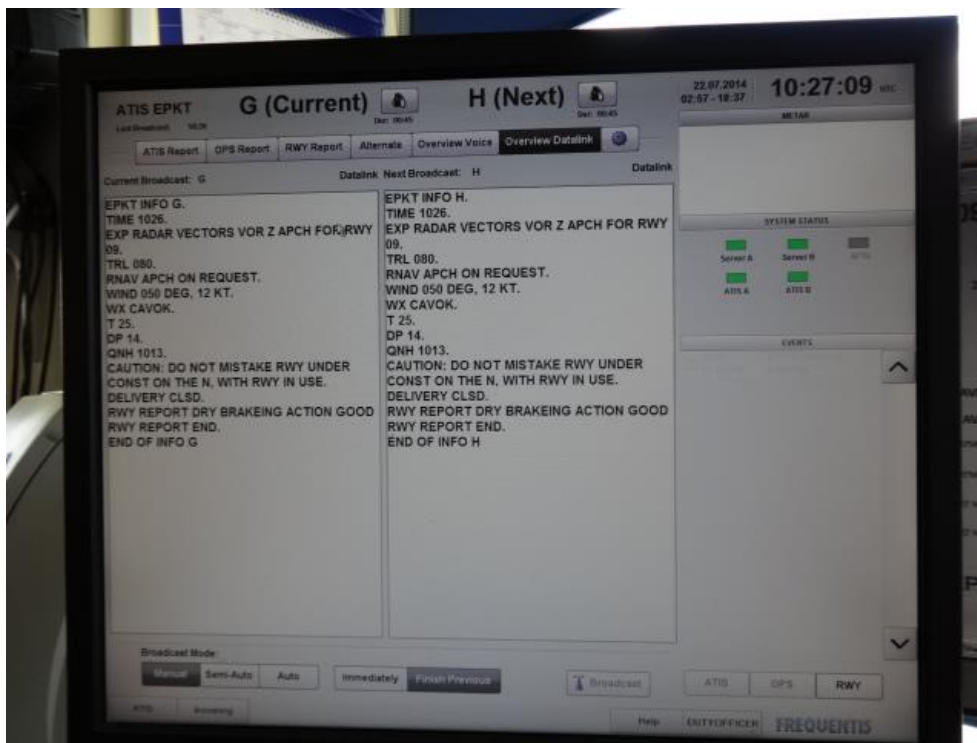
Photo 13. Current ATIS broadcast of the EPKT aerodrome.

According to the SCAAI recommendation and to the procedure implemented on the day of the accident, a warning about possibility of mistakes during landing was introduced into ATIS broadcast.
