FINAL REPORT

ACCIDENT

OCCURRENCE NO – 2018/67

AIRCRAFT – Bombardier DHC-8-402, SP-EQG

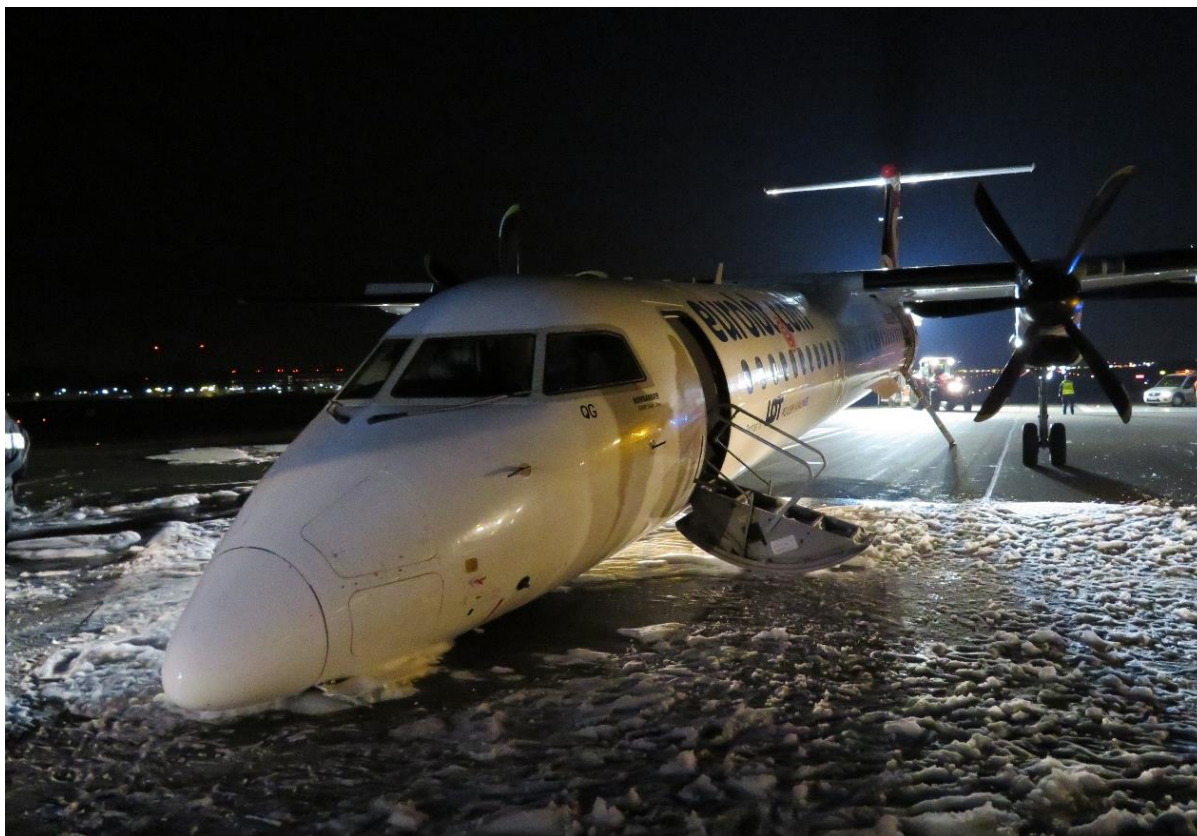
Fig. 1. Bombardier DHC-8-402, SP-EQG, on EPWA RWY11 immediately after the occurrence
[source: PKBWL]²

As a result of the direct contact of the nose part of the fuselage with the runway surface (which resulted from the landing with NLG in the transit position), the plane was damaged to an extent that required repair. Parts of the NLG and the nose-bottom part of the fuselage were damaged.

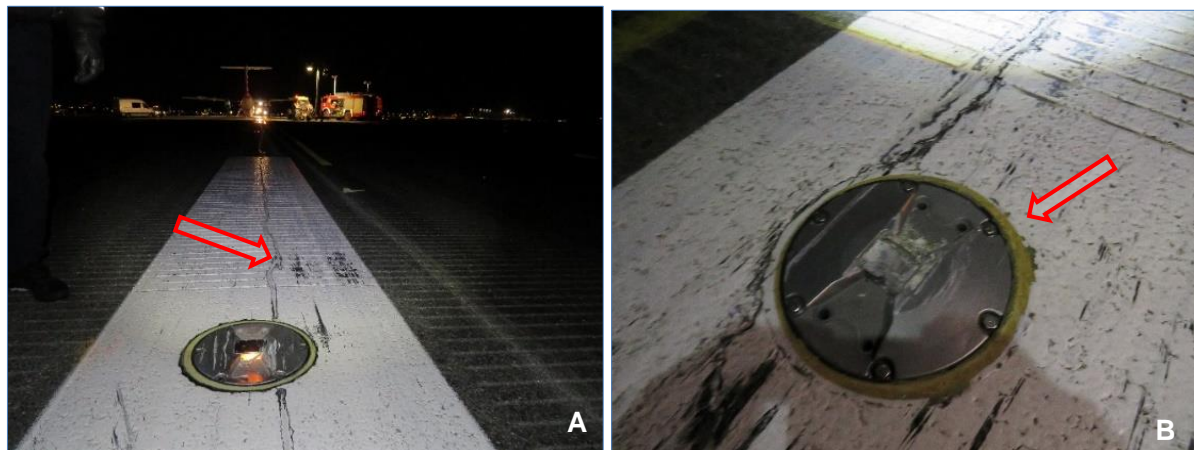
During the landing several lights of the RWY centre line were damaged by the nose part of the fuselage.

Fig. 2. Marks of the emergency landing on RWY11: A – marks left by the fuselage; B – one of the damaged lights of RWY11 centre line

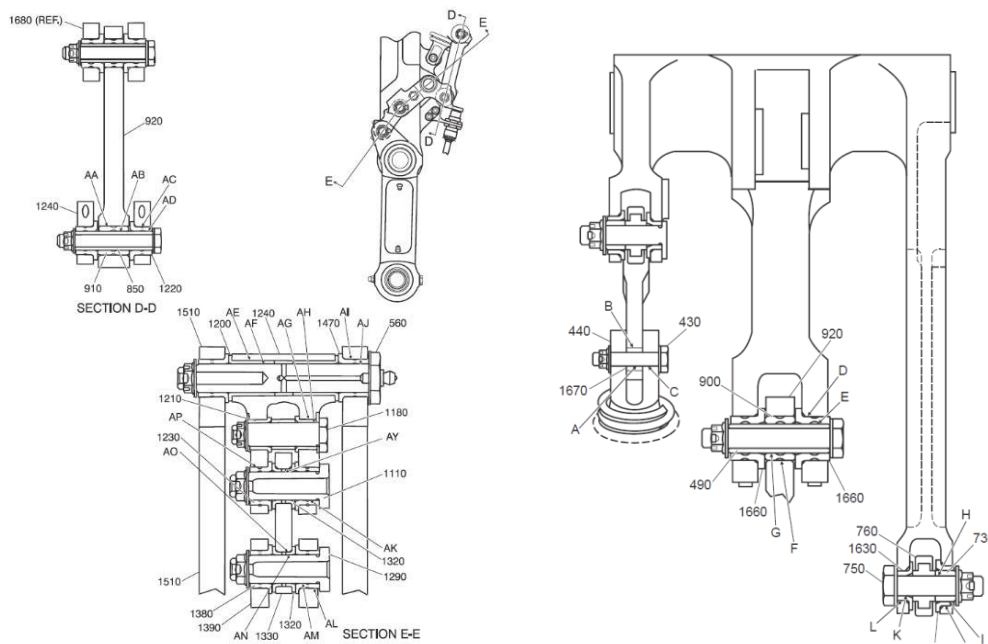
Fig. 17. Designations of selected joints of DSA [source: Bombardier]

- h) Pin, sleeve 47326-13 showed visible damage, grooves and scratches around the whole perimeter. In the place of mating with the lock lever, a particularly significant material loss was found - a furrow with a depth of up to 0.6mm, in relation to the part of the cylindrical surface of the sleeve not mating with the lock lever. The change in the position of the contact surface of the lock lever (LLL) with the sleeve significantly influenced the kinematics of the DSA.

- i) Damage to the LLL, PN 47324-101 resulted in loss of the kinematic link of the mechanism – disconnection of the AN joint (Fig. 17).
- j) The results of the fractographic tests indicated the ad hoc nature of the destruction of the elements provided for testing. No symptoms of fatigue cracks were observed.

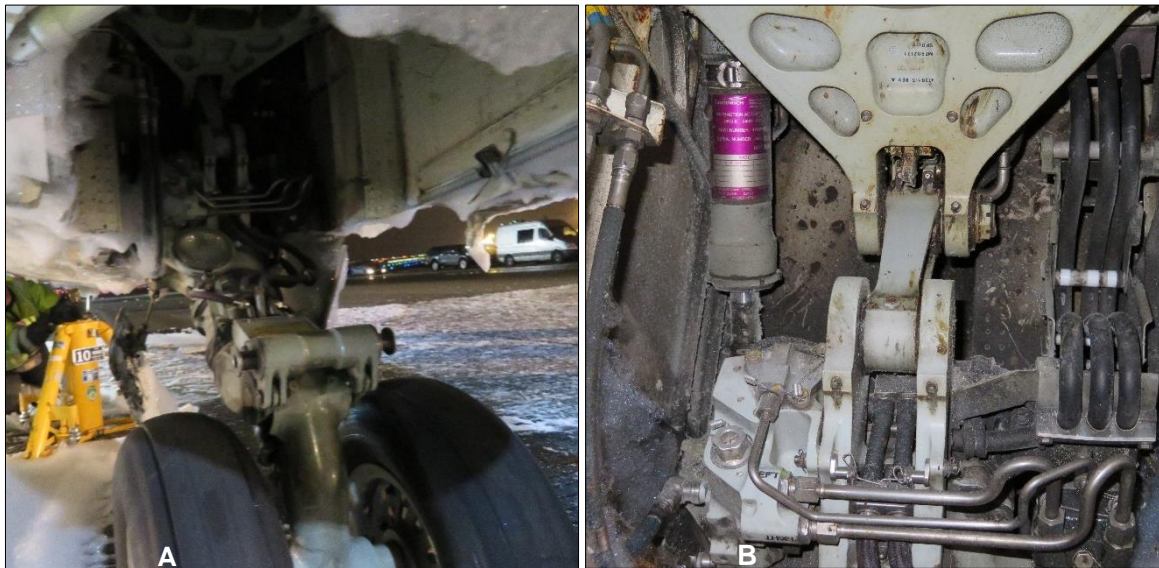
Fig. 26. Lifting the airplane – relative location of the Lower Drag Strut and Upper Drag Strut: A – general view, B – close-up [source: PKBWL].

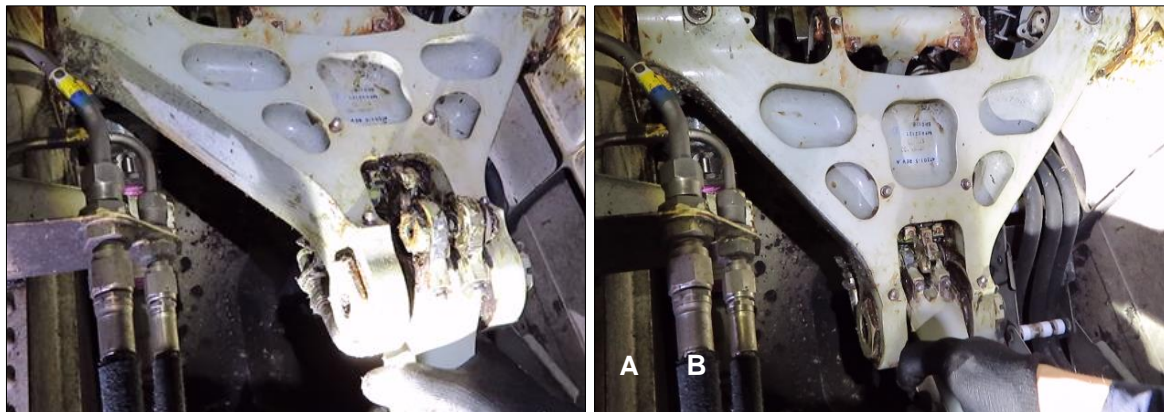
The collision of the above elements was possible only if the DSA folded in the wrong direction (forward), as shown in Fig. 27-A.

Fig. 27. Lower Drag Strut and Upper Drag Strut after lifting the plane: A – strut folded forward (incorrect direction), B – strut folded backwards (correct direction)

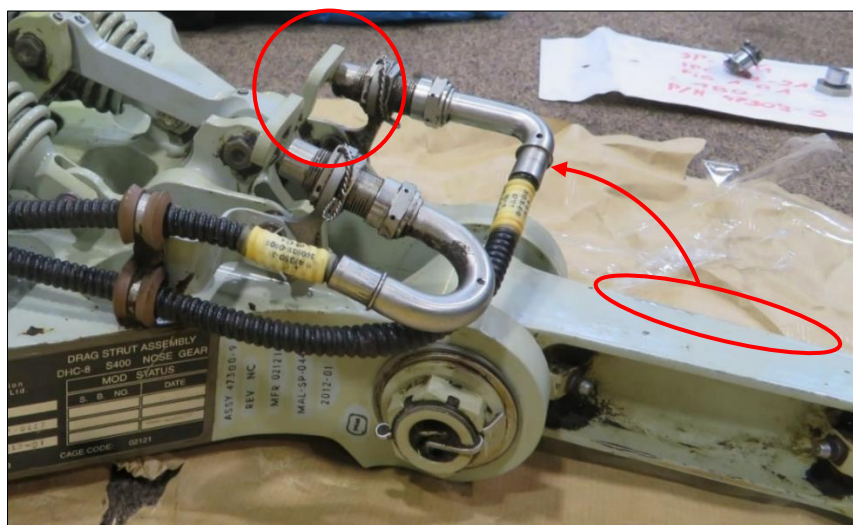
Fig. 28. Drag Strut Assembly - the red circle shows the place of the Proximity Sensor (NGLK2) collision with its target. The red ellipse shows the loss of the paint coating on the Lower Drag Strut and the arrow shows the direction of movement [source: PKBWL].

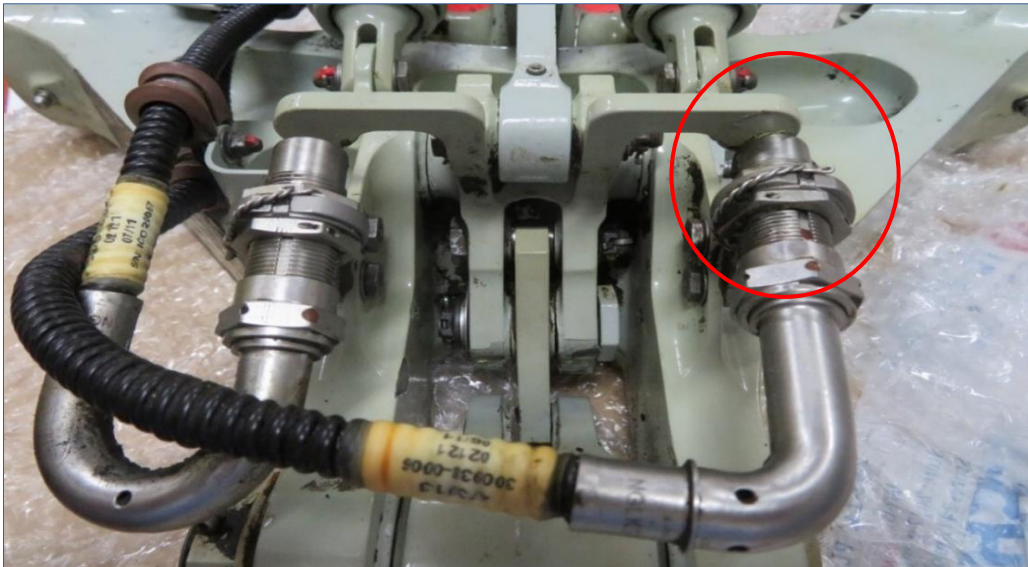
Fig. 29. Drag Strut Assembly – red circle marks the collision of the Proximity Sensor NGLK2 with its target [source: PKBWL]

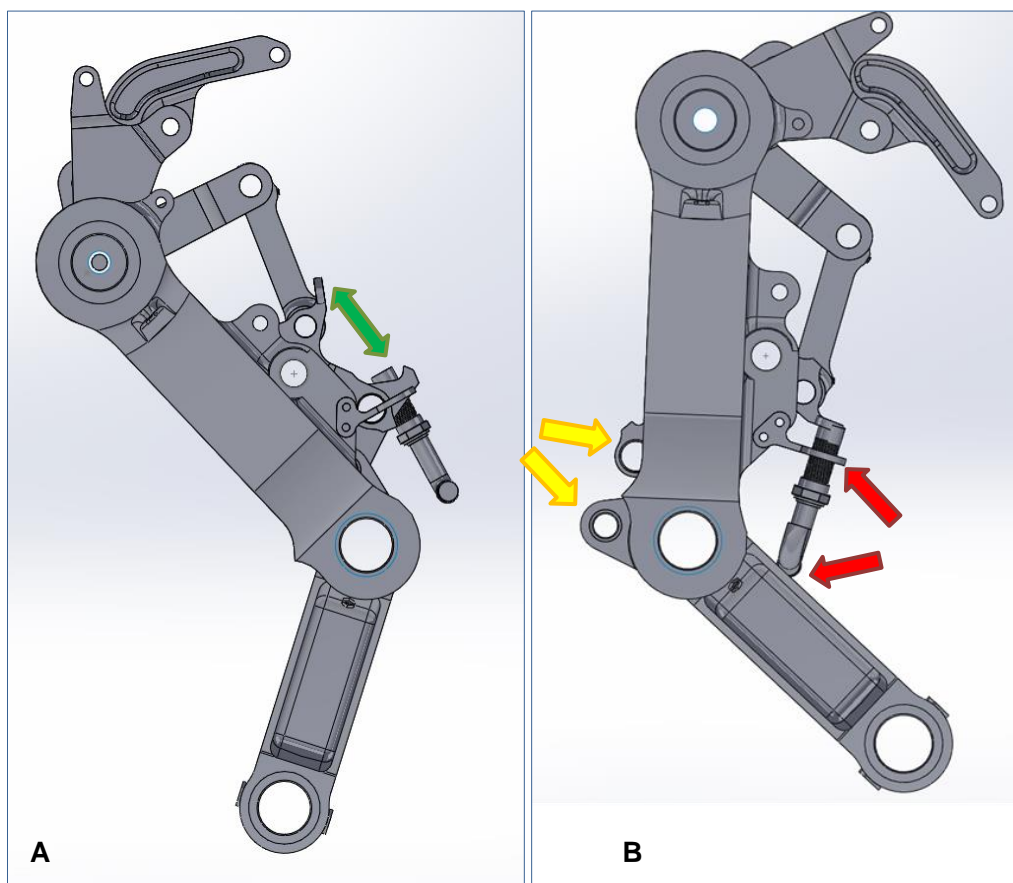
The green arrow in Fig.30-A shows the PS NGLK2 face moving away from its target during the correct folding of DSA and in Fig. 30-B the folding direction in which the LDS collides with ELH.

Fig. 30. NLG DSA in transit position during NLG retraction - side view: A – designed direction of DSA folding, B - opposite direction of DSA folding- incorrect [source: ITWL expert opinion] - A and B markings added by PKBWL

The green arrows in Fig. 30-A show the PS NGLK2 face moving away from its target when DSA is folding in the right direction. The red arrows in Fig. 30-B indicate collision areas when DSA is folding in the opposite direction and the yellow arrows show disconnected link between the LLL and LDS. That link was damaged (torn apart) during the accident.

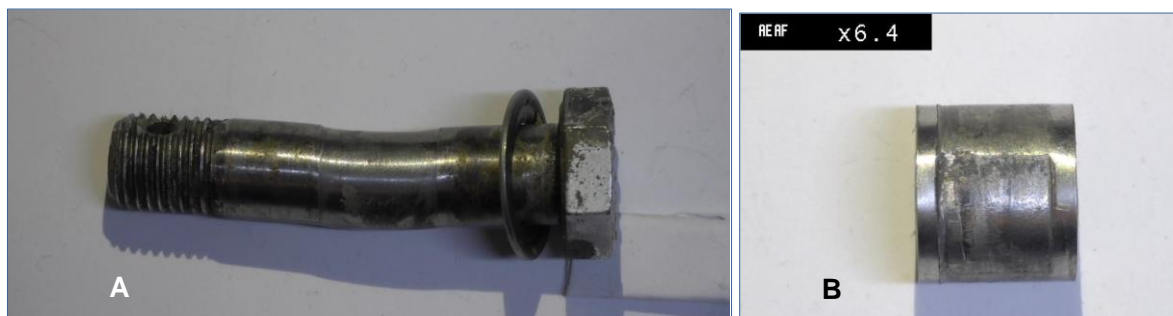
Damage to the sleeve and pin shown in Fig. 32, could have occurred only in the final phase of extension or the final phase of normal retraction of the NLG.

Since the NLG is completely within the contour of the fuselage when retracted, the Stop Pin cannot be damaged when the aircraft nose hits the ground.

The nature of the damage clearly shows that a force acting along the longitudinal axis of the aircraft in the aft direction was applied to the DSA. The force exceeded the limit for which the system was designed.

Fig. 32. View: A - bolt (according to DSA CMM 1-1180, PN NAS6206-20D), B - sleeve (according to DSA CMM 1-1160, PN 47326-13)

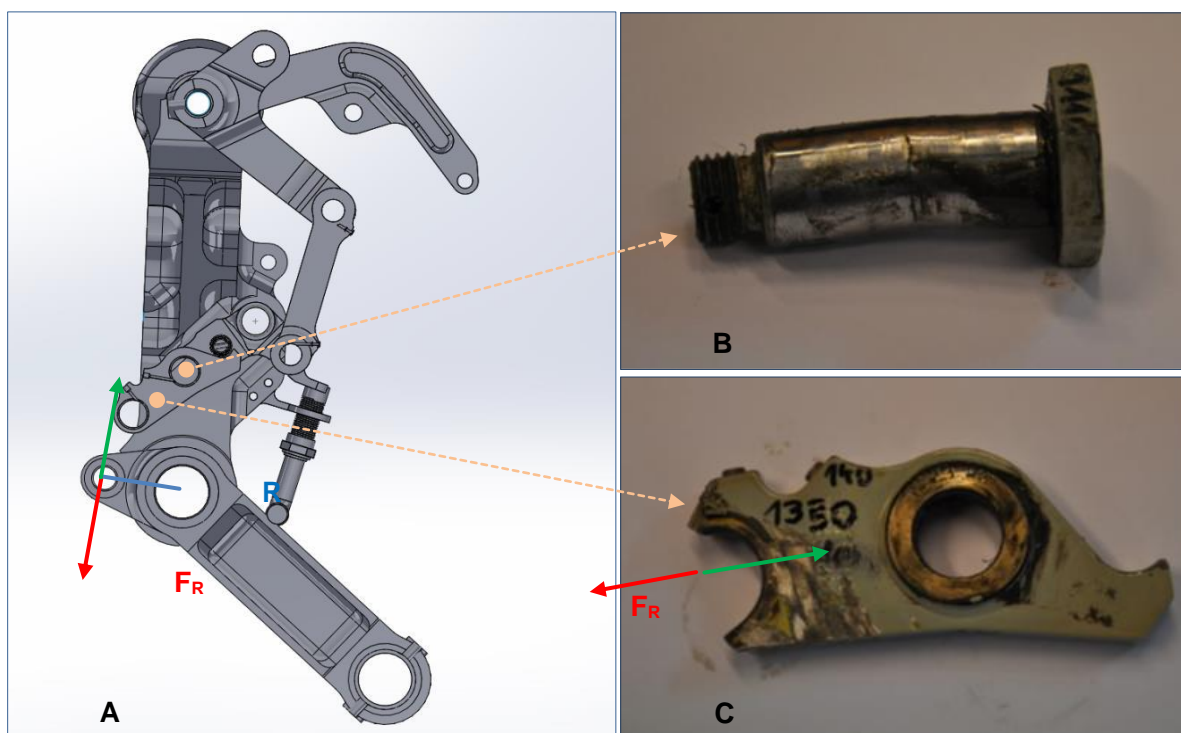
Fig. 33. Nature of damaging the NLG DSA during incorrect retraction of the NLG – cross-section in the longitudinal plane: A – LDS collision with ELH, B – bent bolt (axis of LLL rotation), C – damaged LLL

When LDS and UDS were folding in the wrong direction, the M_R moment (F_R force x R arm) was acting on LLL (through the bolt connecting LLL and LDS) – Fig. 33, red arrows.

The moment (F_R force) had a tearing effect on LLL at its smallest sectional area, which has been confirmed by the nature of the damage shown in Fig. 33-C.

During the proper retraction of the NLG, the force would have the opposite direction (green arrows), therefore it could not have caused the existing damage.

Damage (bending) of the LLL bolt (Fig. 33-B) indicates that the rotation of the bolt was blocked, which occurs when LLL rests on the stop pin.

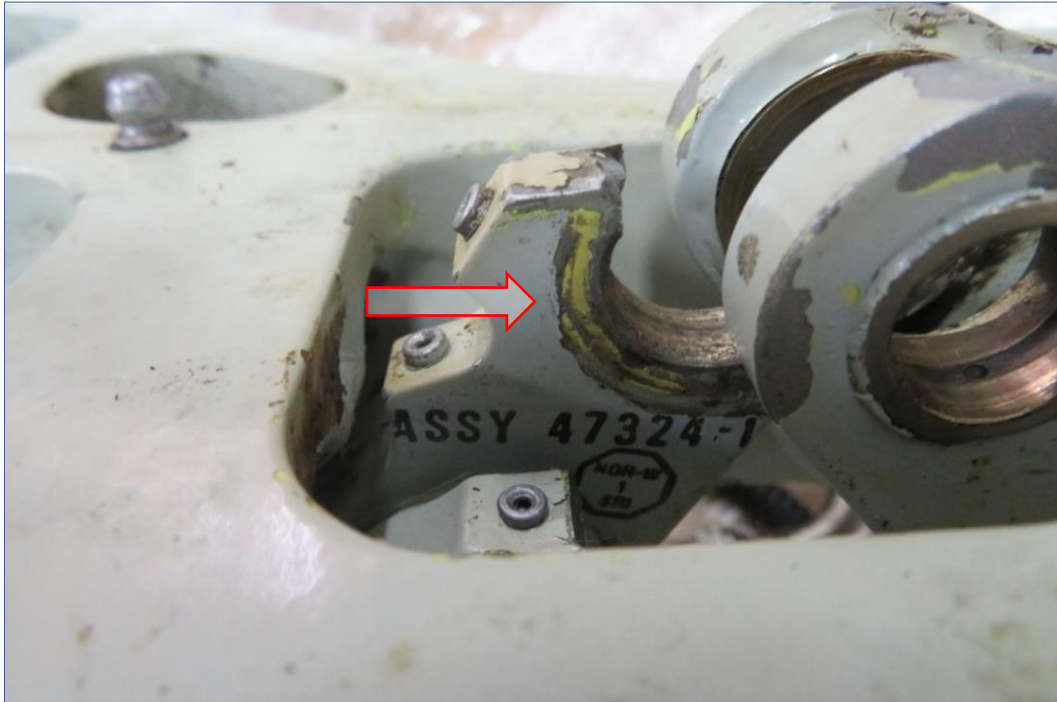
Fig. 36. Lower Lock Link from SP-EQG plane damaged during the occurrence
