# FINAL REPORT

OCCURRENCE NO. – 2022/3285

AIRCRAFT – Cessna TU206G, OK-ROY

DATE AND PLACE OF OCCURRENCE – 24 June 2022, EPBA

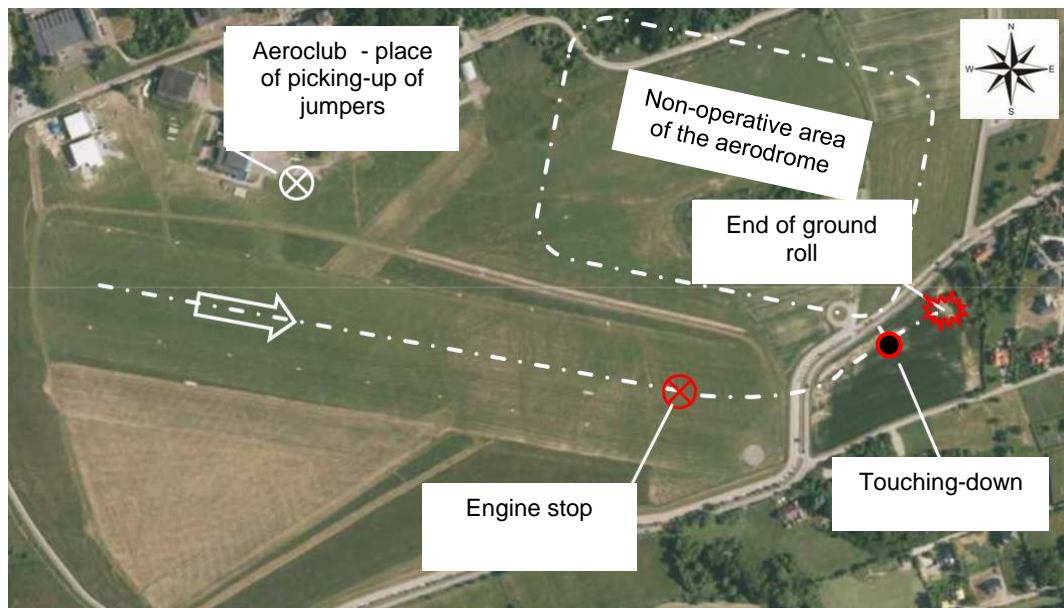
The second take-off took place at 17:09, using the full length of the grass RWY 09 (Fig. 1). During the climb, the aircraft engine stopped. Being at an altitude of about 20 m above the ground, the pilot went into a gliding flight and, turning about 40÷45° to the left, made an emergency landing on a small cultivated field adjacent to the airfield (Fig. 2).

**Fig. 1.** Take-off trajectory and forced landing site [source: Geoportal]

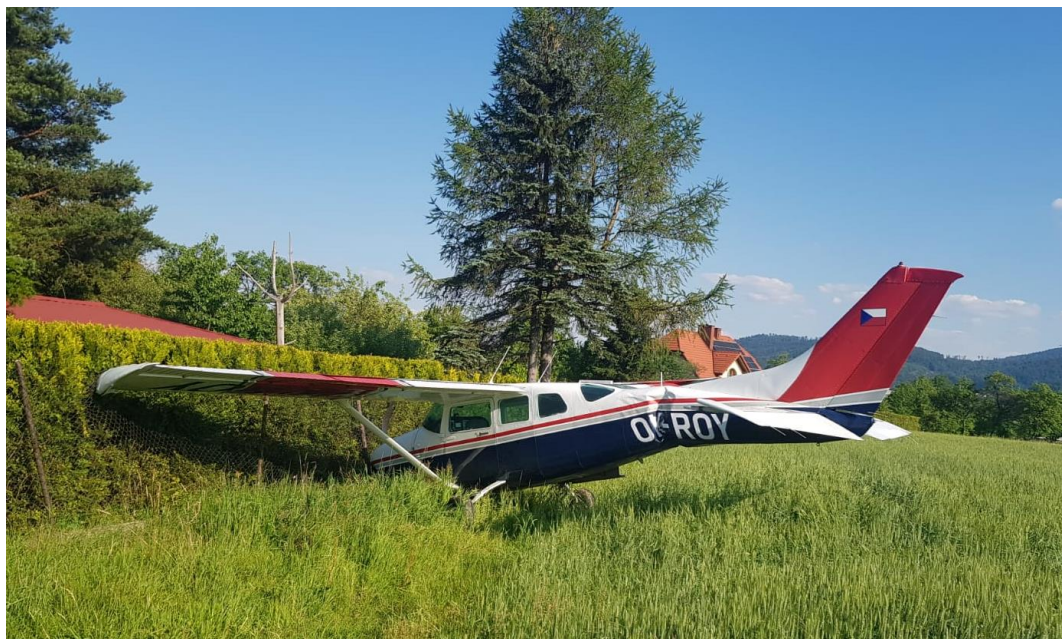
During the landing a very hard touchdown took place with a short run ended with a collision with the fence of the property, which resulted in breaking the front landing gear and bending the propeller blades.

**Fig. 2.** Location of the aircraft after stopping on the fence of the property [source: SCAA]

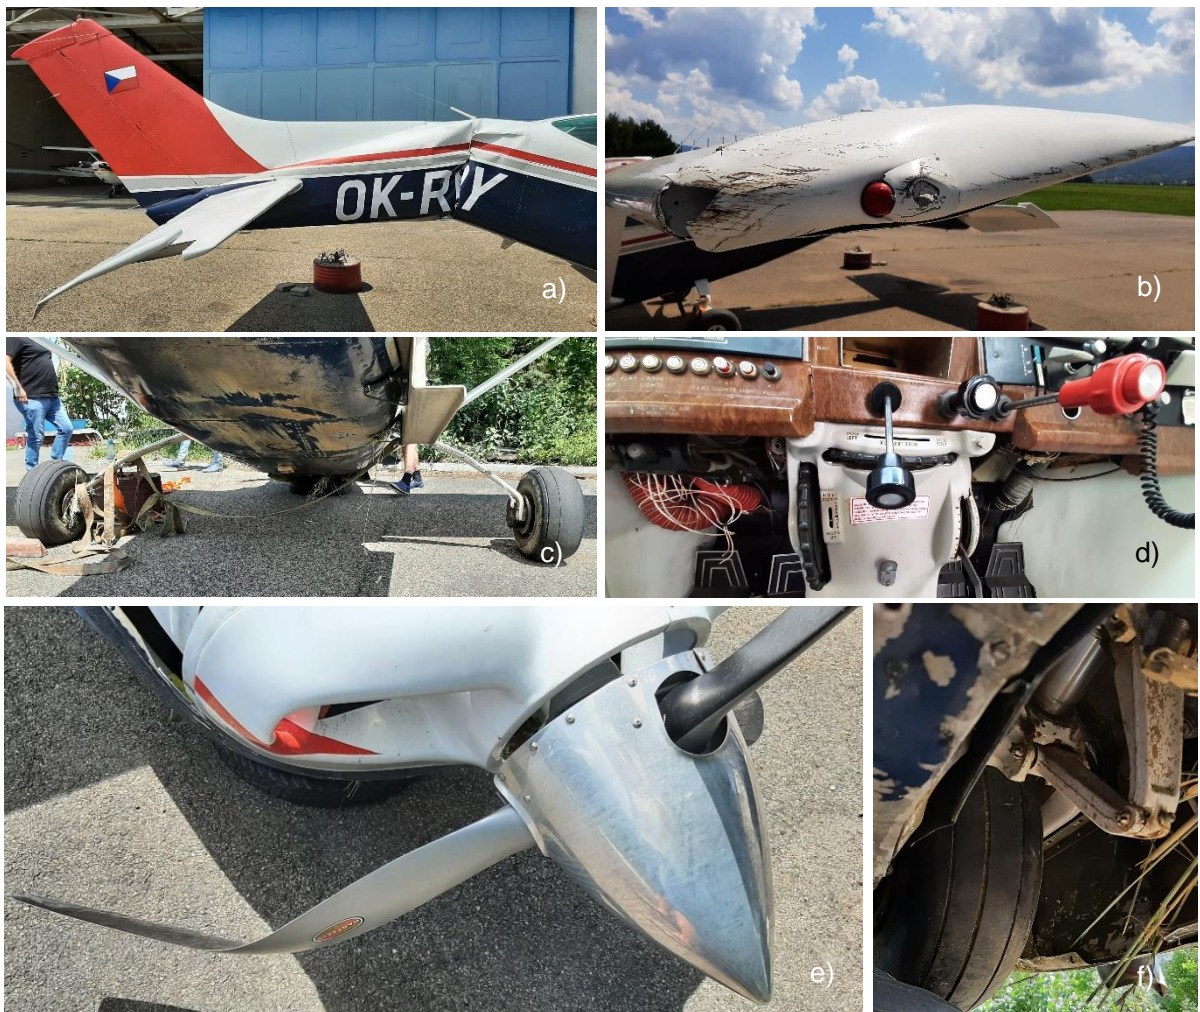
The plane sustained serious damage (Fig. 3). As a result of a very hard touchdown, the fuselage broke behind the passenger cabin. The elevator drive broke as well.

Undulations of the cover were found on the right side of the fuselage, behind the entrance to the cabin, and cracks in the cover near the connection of the wing struts with the fuselage.

The bench for jumpers was detached from the fasteners on the floor and destroyed. The engine control lever (throttle lever) from the cabin was bent, the engine cowling flaps control lever console broke, and the backrest of the pilot's seat was deformed. The upper hinge of the left cabin door was torn off (cut).

The main landing gear and the fuselage in the front fork mounting area sustained structural damages, and the front fork together with the wheel was broken and pressed into the engine compartment. All 3 propeller blades were destroyed (bent).

The windshield in the cabin was detached from the lower part of the frame.

The tip of the left wing and the right half of the elevator were damaged.

**Fig. 3.** Damage to the aircraft: a) broken fuselage, b) left wing tip damage, c) scratches on the bottom part of fuselage and main landing gear, d) bend on the throttle lever, e) bent prop blades, f) broken front undercarriage fork, pressed into engine compartment [source: SCAA]

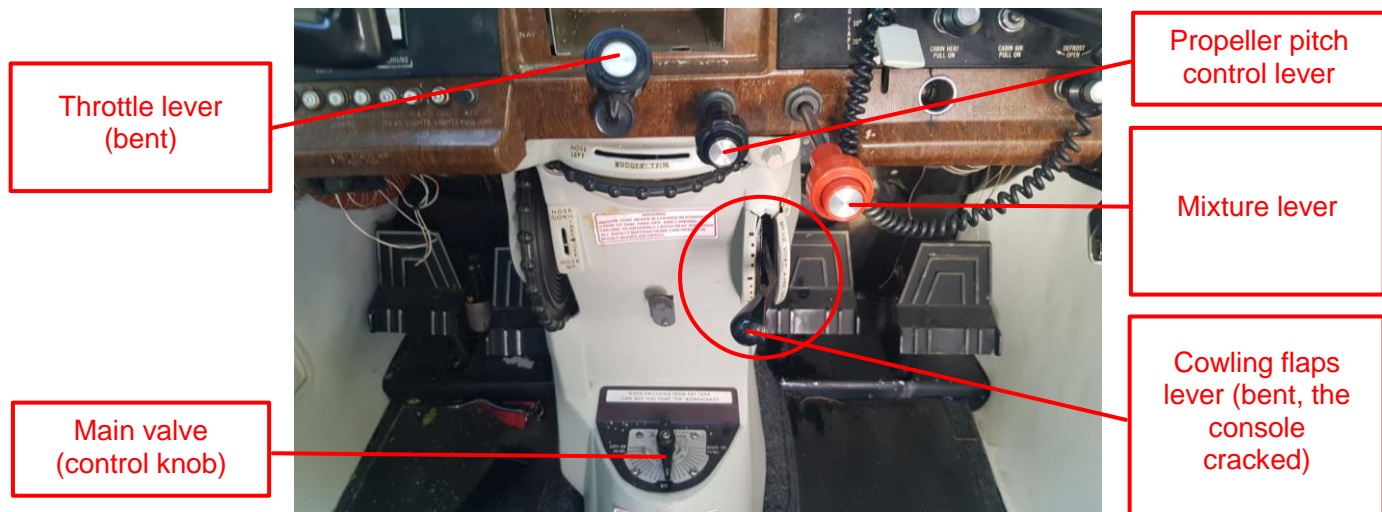
Fig. 4. Setting of engine control devices after an emergency landing [source: SCAA]

**The control knob for the fuel valves** - the outflow of fuel from the tanks - was in the "OFF" position (closed valves), according to the pilot's statement. This was the correct position to prevent the occurrence of a fire after an emergency landing – closed valves cut off the fuel supply to the engine compartment.

**The throttle lever** (curved, bent upwards) was in the "fully back" position (choked rpm).

**The propeller pitch control lever** (in the middle) remained in the "fully forward" position and this was the right position for take-off/landing (low pitch).

**The mixture control lever** (handle in red) was completely retracted (to the "lean" position), which corresponds to the process of shutting down the engine. It was the correct position to touch down and prevent a possible fire.

In addition, **the engine cowling flaps control lever** (engine cooling in flight) was curved and its plastic casing was cracked.

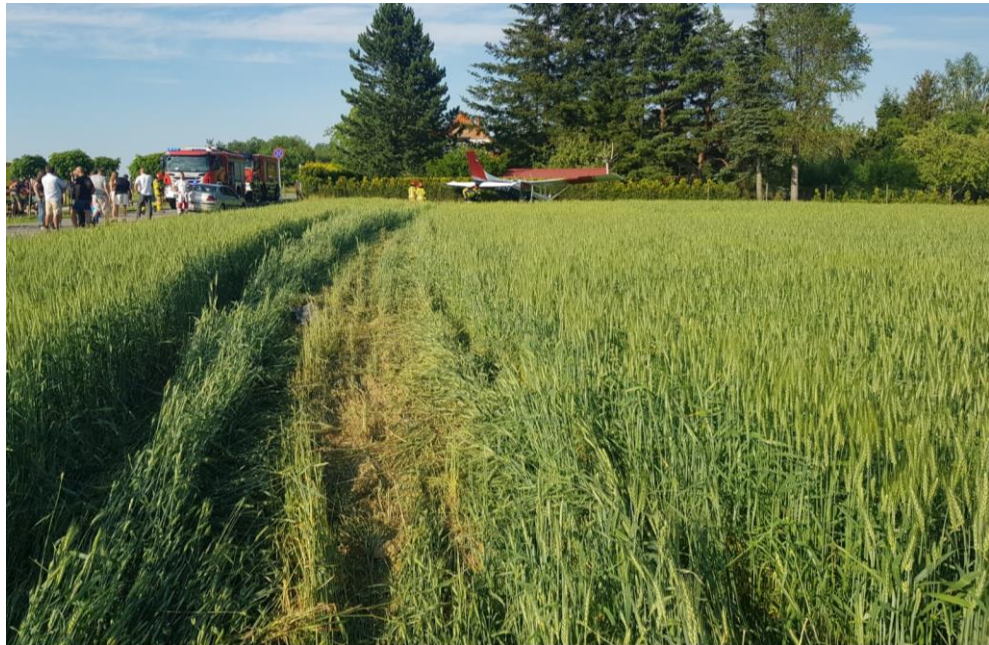
After hitting the ground, the pilot tried to keep the direction of roll-out away from the bike lane. The roll-out, in an arc (Fig. 7 and Fig. 8), ended with a collision with the metal

The rapid deceleration on the roll-out was caused by the minimum touchdown speed, torsion of the bottom part of fuselage and propeller. And above all – by high cultivation (grain). The pilot used wheel brakes also.

**Fig. 7.** View of the plane, bike lane and traces of roll-out in the grain [source: SCAA]

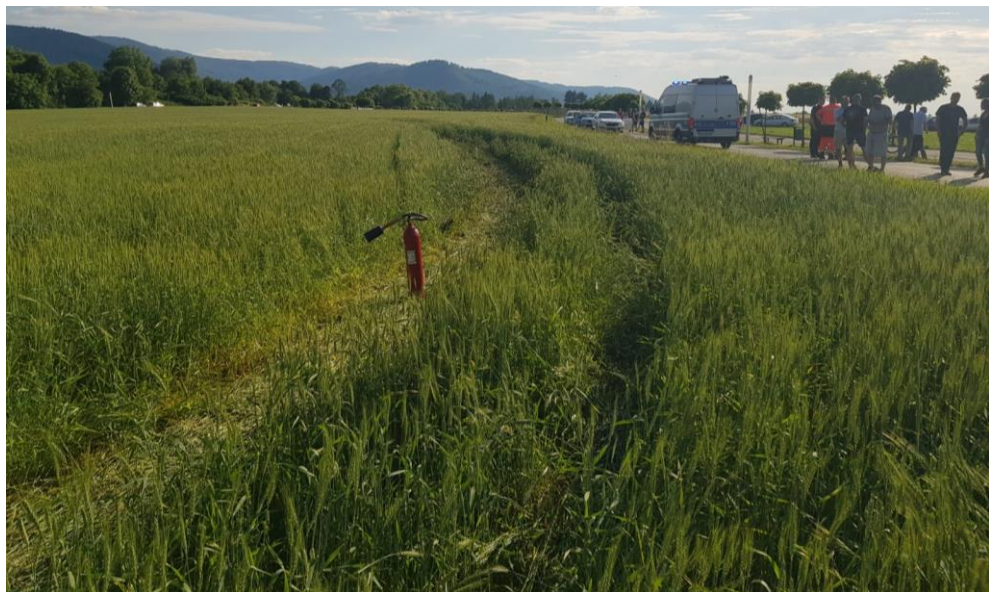
**Fig. 8.** View in the opposite direction to the landing, from the place where the aircraft stopped. EPBA aerodrome is on the right, just behind the bike lane [source: SCAA]

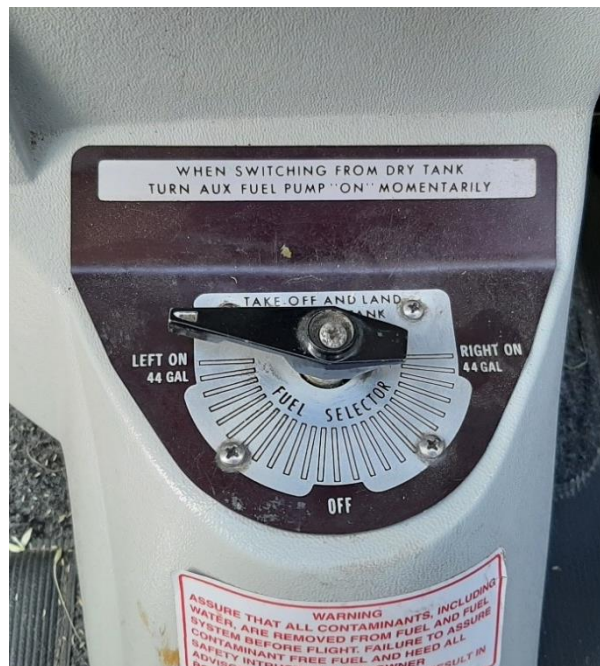
In order to determine whether the valve (Fig. 9) was operational, both tanks were refueled – then the valve were working properly.

**Fig. 9.** Fuel valve in the cockpit – the valve knob (in black) controls the fuel supply from the tanks to the engine compartment [source: SCAA]

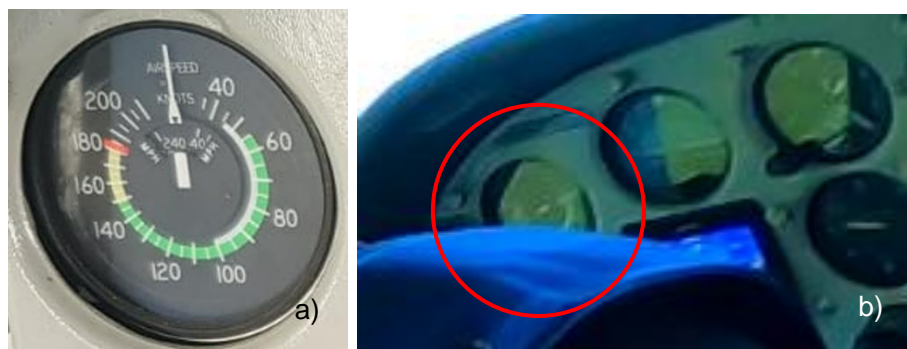
After 25 s from the first move (beginning of run-up), the aircraft was about 150 m from the fence surrounding the aerodrome on its eastern end and – accelerating – the speed of about 55÷60 kt (102÷111 km/h). This speed was determined on the basis of video footage recorded by the camera of one of the jumpers (Fig. 11).

**Fig. 11.** a) Airspeed indicator (ASI) with its marking, installed in OK-ROY, b) ASI readings recorded in 27 s of flight, i.e. 2 s after engine power loss [source: video footage recorded by the camera of one of the jumpers]

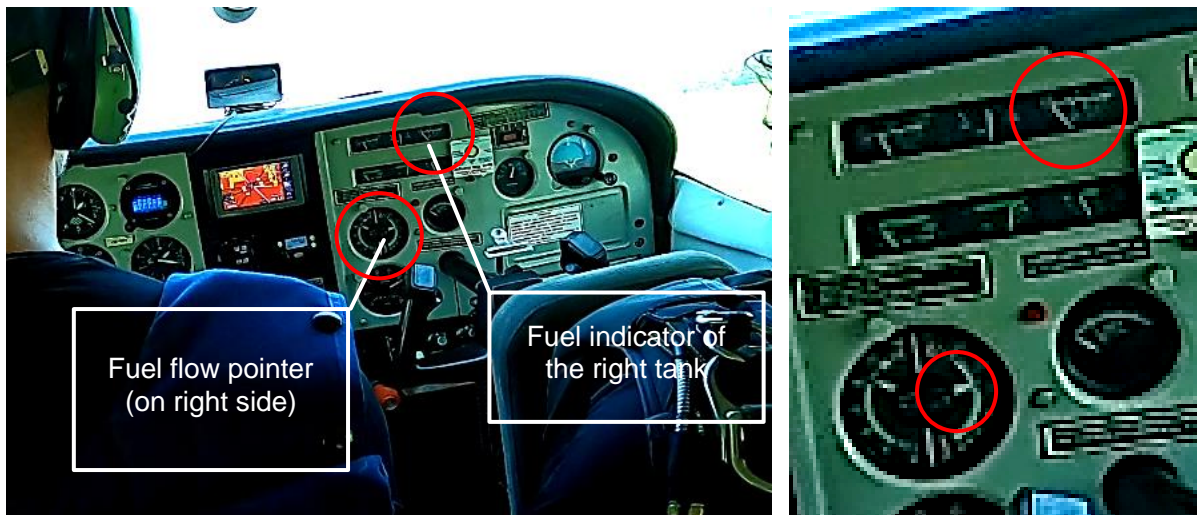
The situation in 7 s<sup>7</sup> from the beginning of ground roll is shown in Fig. 12. There was a minimum amount of fuel in the right tank – the fuel meter pointer was in the extreme left position and the fuel flow was very high, which was in accordance with the engine operating conditions at full take-off power.

**Fig. 12.** View of the instrument panel in 7 s from the beginning of run-up. The figure on the right shows the enlargement of a fragment of the instrument panel and marks the fuel meter and flow meter [source: video footage recorded by the camera of one of the jumpers]

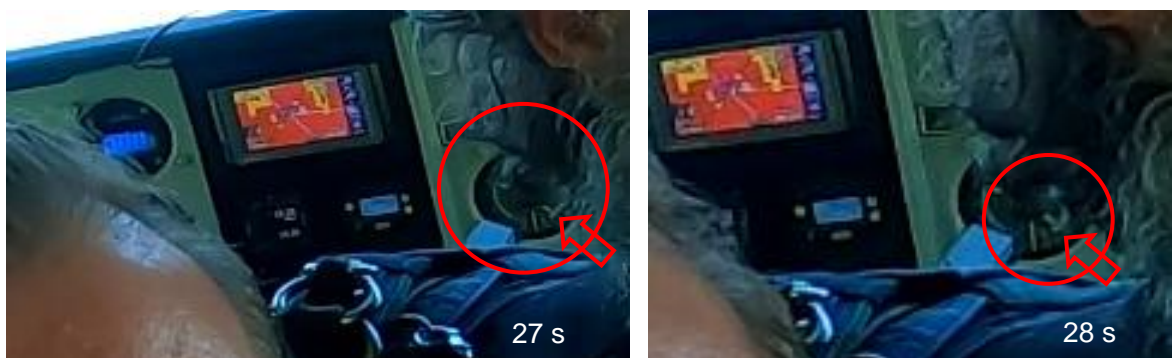
Fig. 13 shows the flow meter readings in 27 and 28 s after the beginning of the run-up, and therefore 2÷3 s after the engine shuts down. A decrease in fuel flow to zero is visible, which means that the engine did not receive fuel. This resulted in propeller rpm decreasing to the speed of wind-milling and shutting down of the engine.

**Fig. 13.** Drop of readings on the flow meter: the red arrow shows the position of the instrument pointer [source: video footage recorded by the camera of one of the jumpers]

The above facts, in combination with the complete lack of fuel in the right wing tank, prove that during the previous flight and the take-off ended in an accident, the fuel valve in the cabin was set in a position that allowed fuel to be drawn only from the right tank.

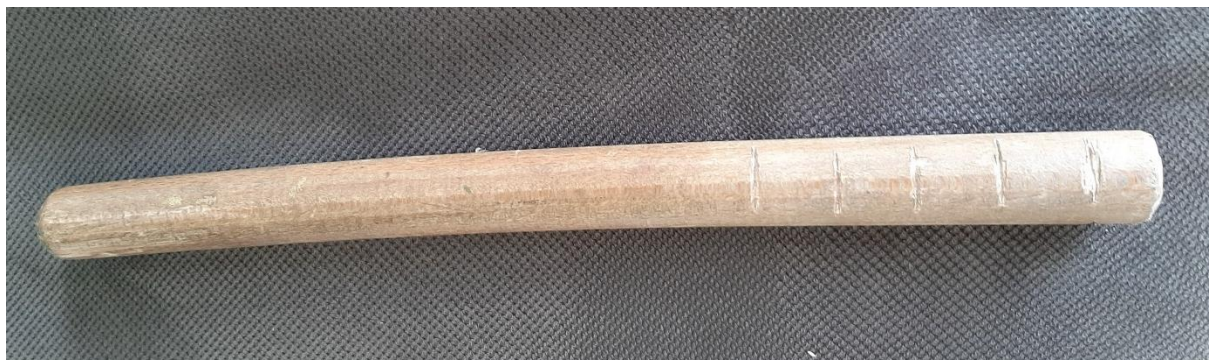
It should be noted that during the pre-flight inspection (before the first flight), the pilot checked the fuel status directly in the tank, measuring its level with the pin shown in Fig. 14.

**Fig. 14.** Wooden pin with cut scale, used to check the amount of fuel in the tank [source: SCAAI]
