State Commission on Aircraft Accidents Investigation

# FINAL REPORT

2024-0057

**Salt Aviation Sp. z o. o.  
Robinson Helicopter Company R44 Cadet SP-NHM**

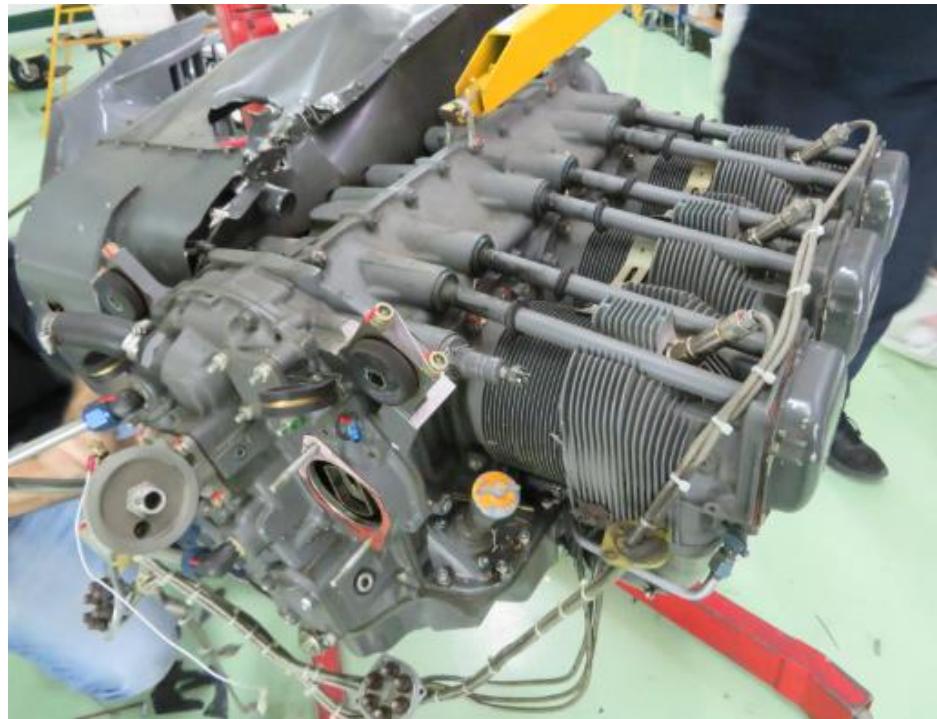
Fig. 6. Engine removed from the helicopter involved in the incident.

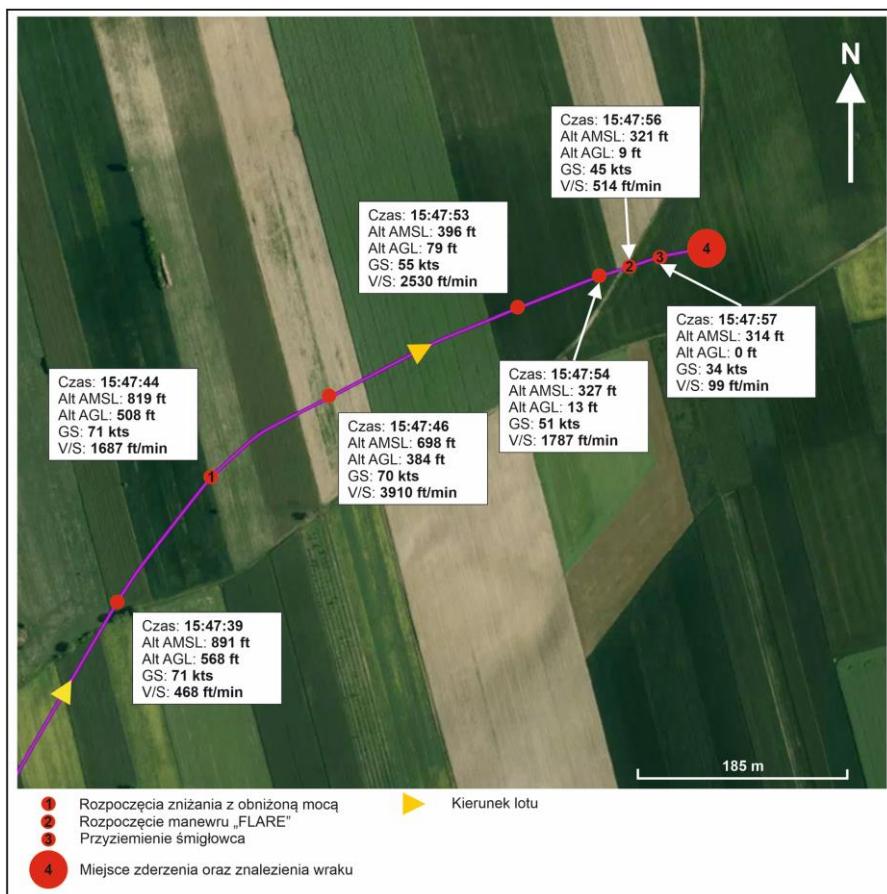
Fig. 9. The site of the air incident in question with the trajectory plotted.

Touchdown occurred at a speed of approximately 35 kt.

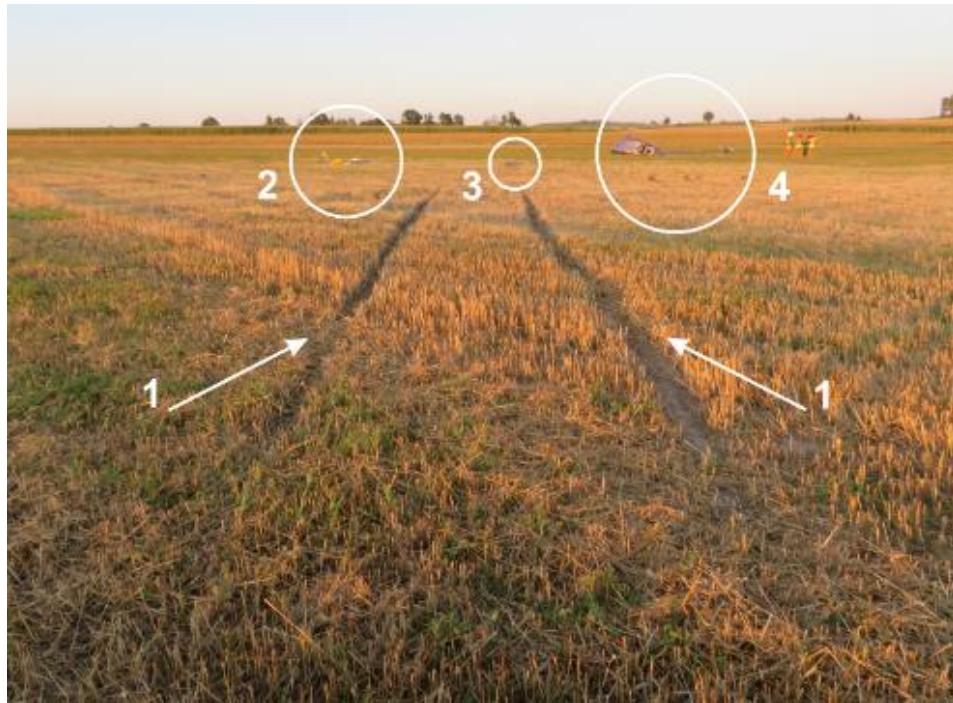
Fig. 11. The crash site as seen from the direction of landing. 1 - traces of touchdown and run-up; 2 - fragments of the lifting rotor blades, 3 – front parts of the skids, 4 – helicopter wreckage with the tail boom and broken tail rotor gearbox and stabilisers.

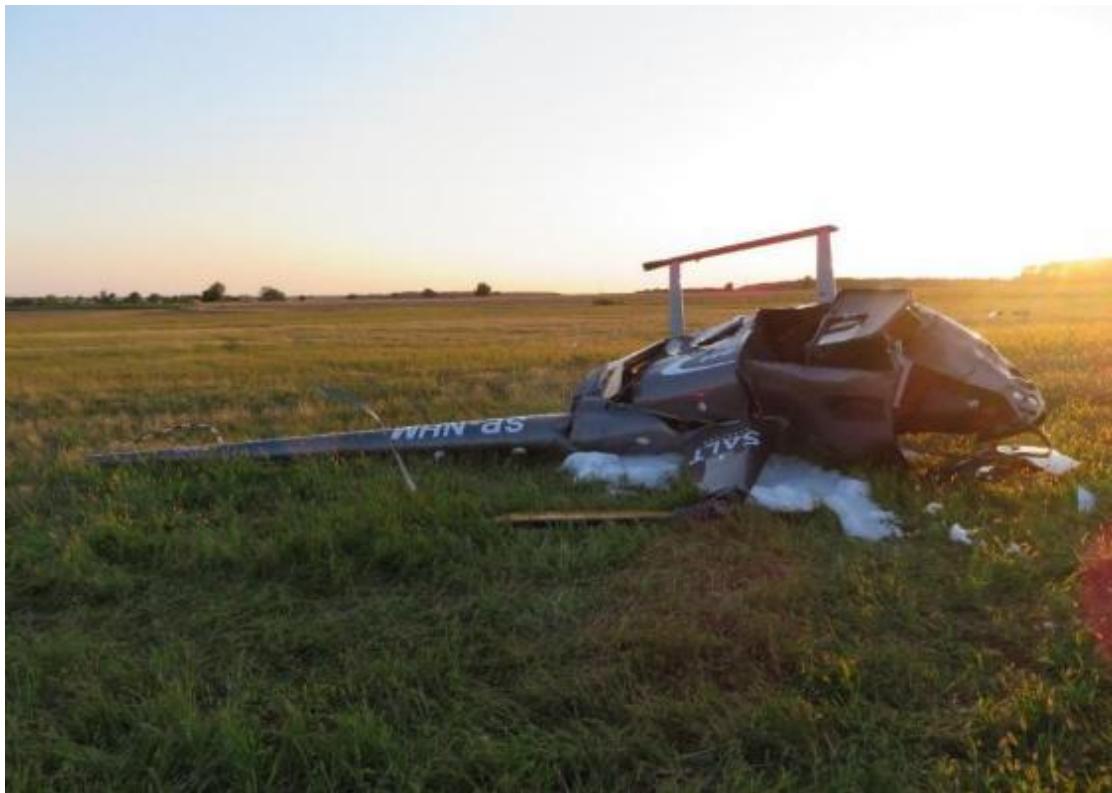
The wreckage of the helicopter (Fig.12) was located approximately 20 metres from the first touchdown mark. The fuselage lay on its right side along with the broken tail boom and separated stabilisers along with the tail gear and tail rotor (there were no signs of ground contact on the tail skid). Approximately 10 metres beyond the run-in marks were detached front skid pieces along with fragments of the left front door.

Fig.12. Wreckage of the helicopter.

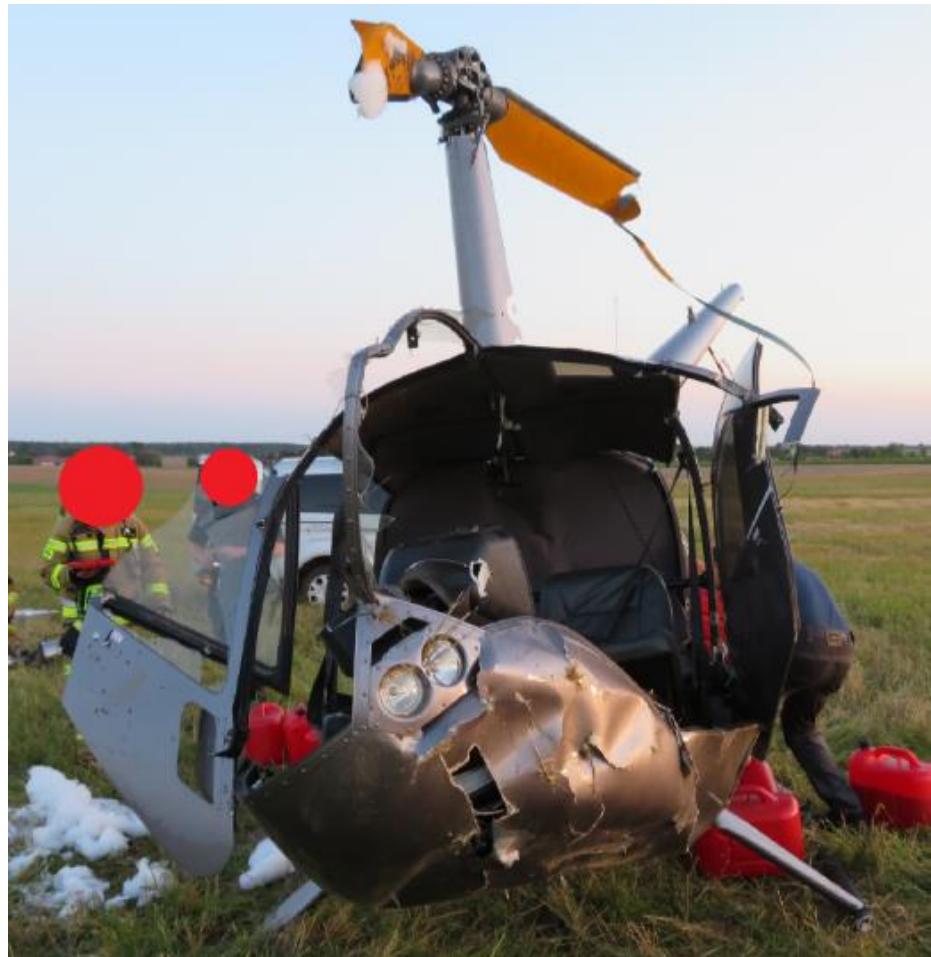
The two lifting rotor blades separated as a result of the impact on the ground (Fig.13). The first blade separated at the very root the second about 1 meter from the root.

Fig. 13. Deformed helicopter cockpit.

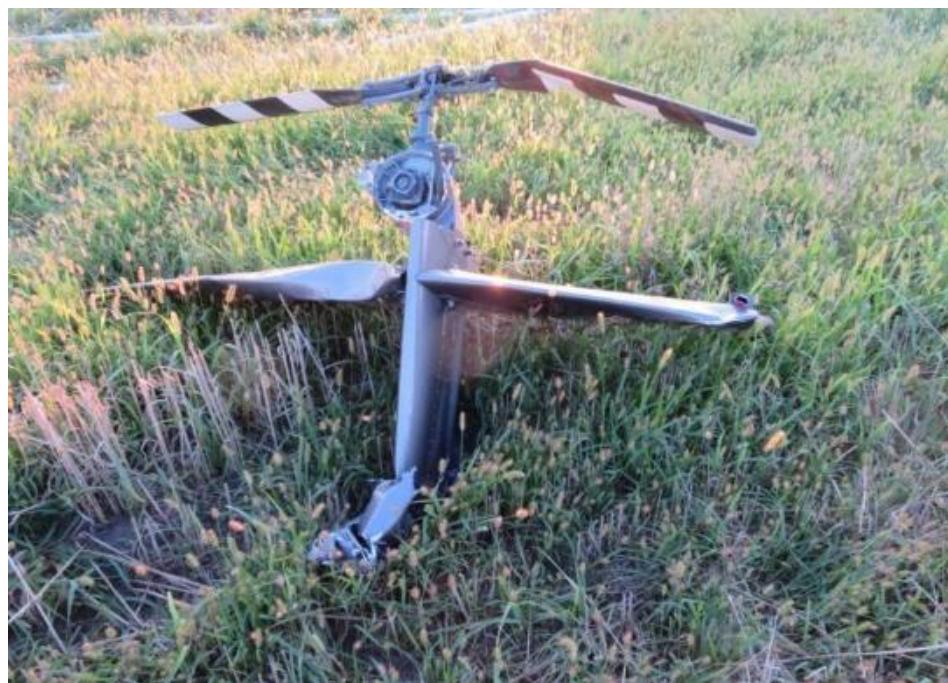
The tail rotor was slightly bent (Fig. 14), which indicates that it was not operating at the moment of contact with the ground. The helicopter struck the ground with the horizontal stabiliser, which caused the tail rotor gearbox and its attachment along with the stabilisers to detach from the tail boom.

Fig. 14. Separate tail rotor gearbox including tail rotor and stabilisers.

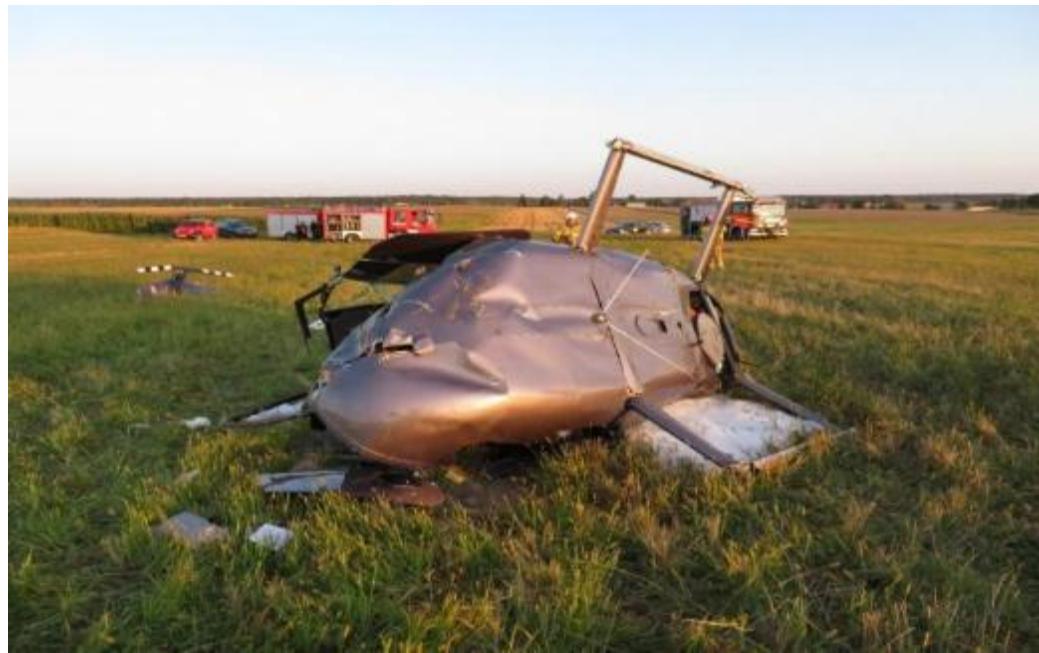
Fig.15. Visible damage to the lower part of the fuselage.

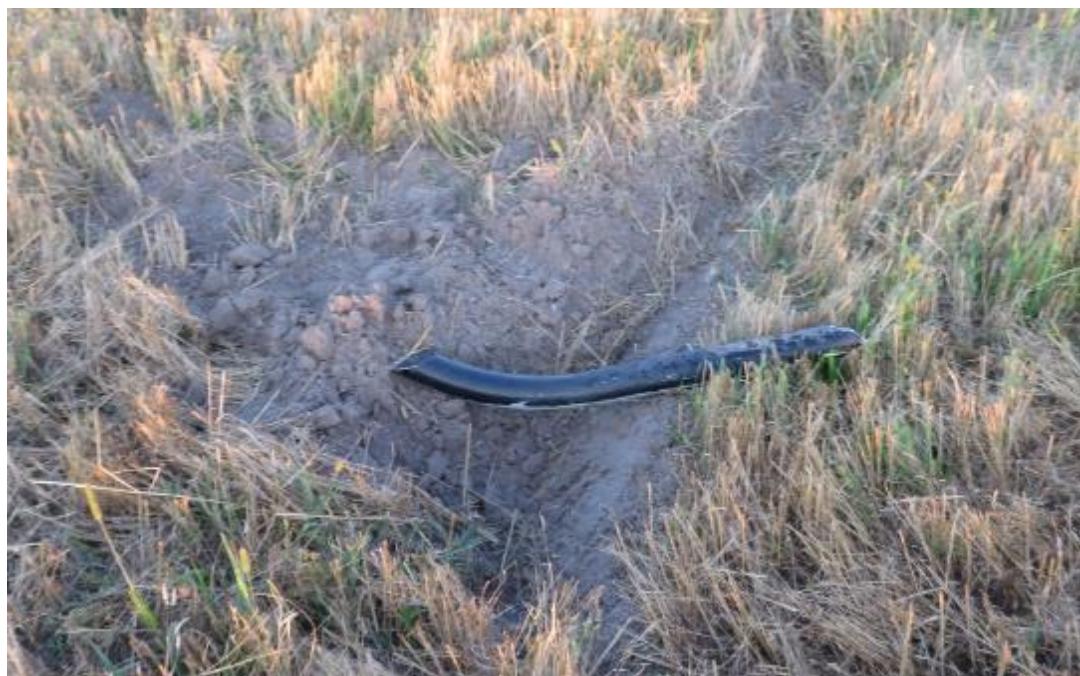
There were traces of their contact with the ground where the front skid fragments of the helicopter were found (Figures 16, 17). At this point, the helicopter made contact with the ground again.

Fig. 16. Separated right skid section.

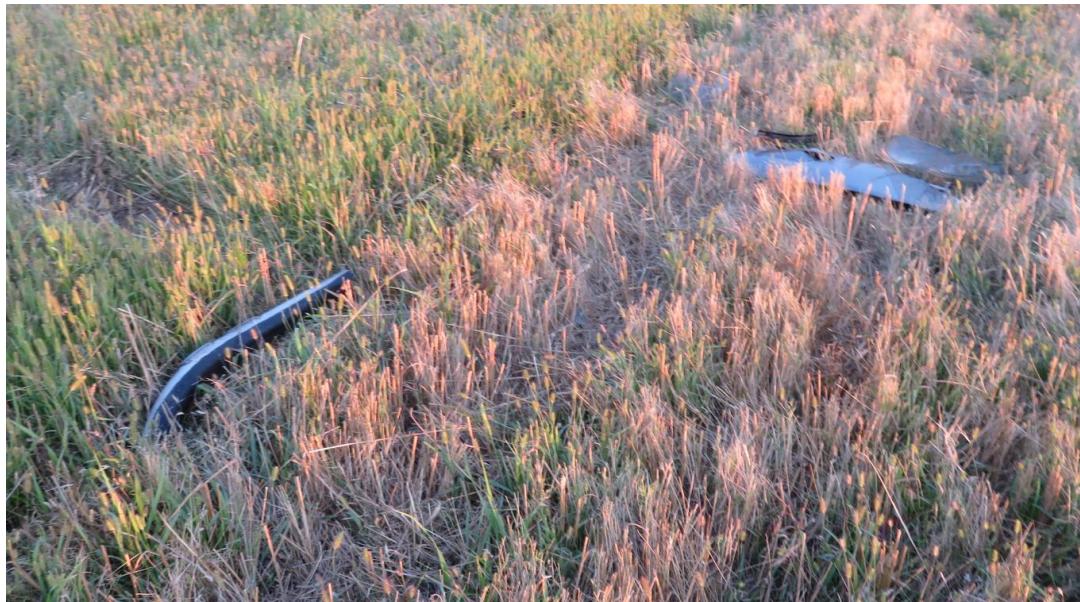
Fig. 17. Separated left side of skid and left front door.

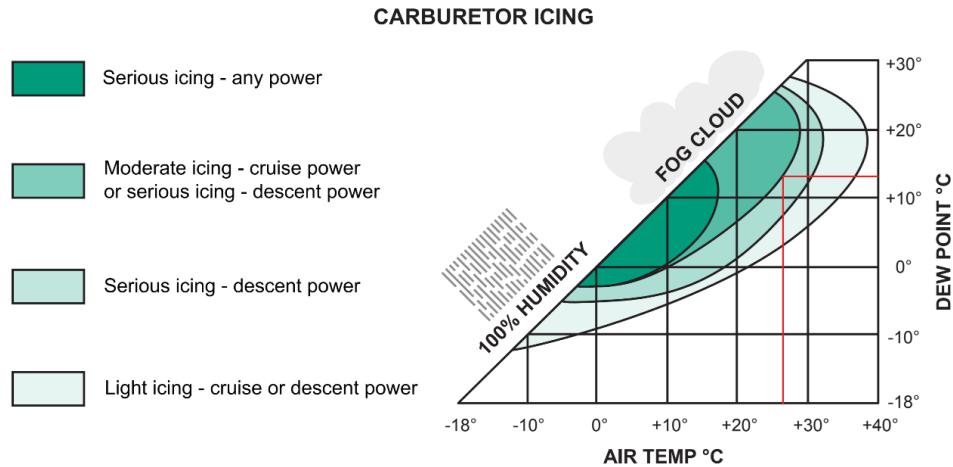
Fig. 18. Diagram of the possibility of carburetor icing - red lines indicate prevailing weather conditions at the time of the incident [source: TCCA].

According to the diagram at the time of the incident, high carburetor icing may have occurred for cruising power, and severe icing may have occurred during descent. In contrast, the possibility of carburetor icing at full power during climbing is negligible. In addition, the pilot stated that he had turned the carburetor preheat up to half while passing through an altitude of 1,000 ft AMSL. This cannot be confirmed because the stroke lever is correlated with the carburetor heater – when it is lifted up (increasing power), it closes the heater.

Based on the above analysis, it was concluded that carburetor icing was not the cause of the fluctuations.

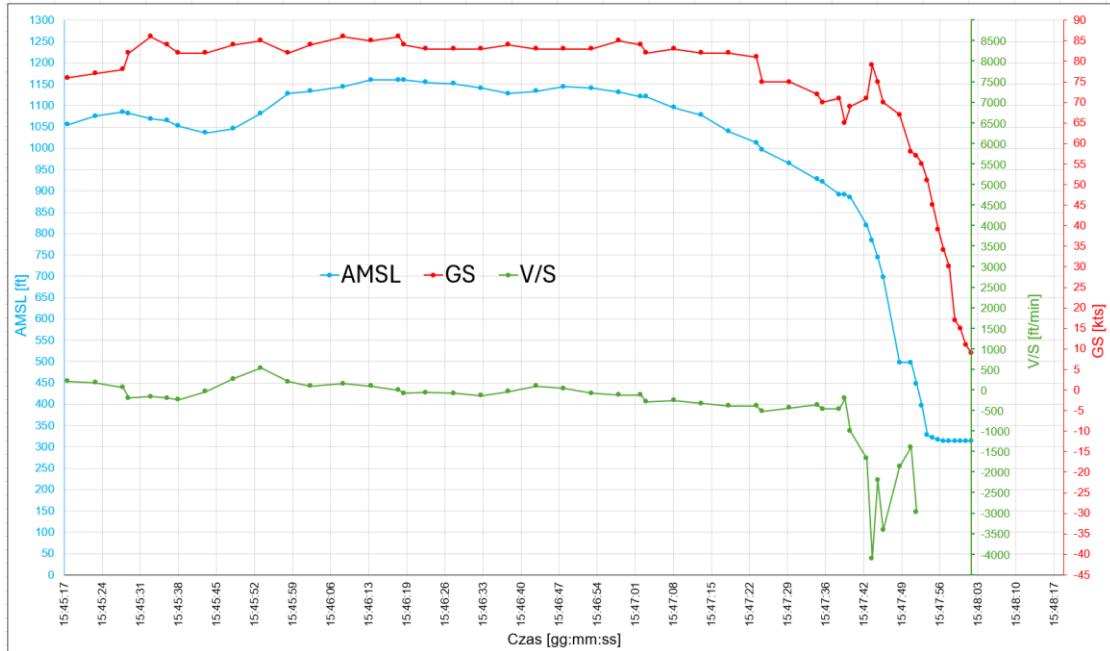
Fig. 19. Parameters of the final phase of the flight.

Approximately 90 seconds before impact, the helicopter began to lose altitude with an average descent of 300 ft/min (highest value minus 526 ft/min). By the time the decision was made by the pilot, it had lost 259 feet of altitude. This is a slight drop in altitude, but may prompt a decision to make a precautionary landing.
