FINAL REPORT

ACCIDENT

OCCURRENCE NO – 2018/67

AIRCRAFT – Bombardier DHC-8-402, SP-EQG

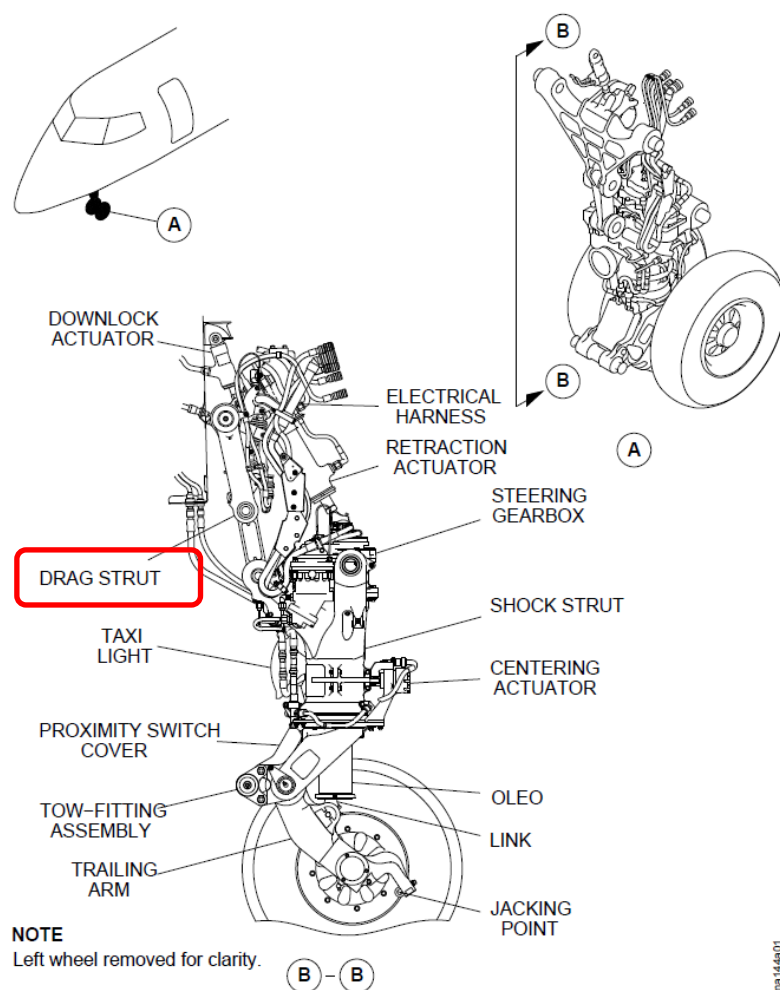
Fig. 4. Main components of the NLG, where: A – location of the NLG, B-B view in the longitudinal plane of the aircraft. Red frame shows the name of the component which was damaged during the accident (details in Chapter 1.3) [source: AMM 32-21-00]

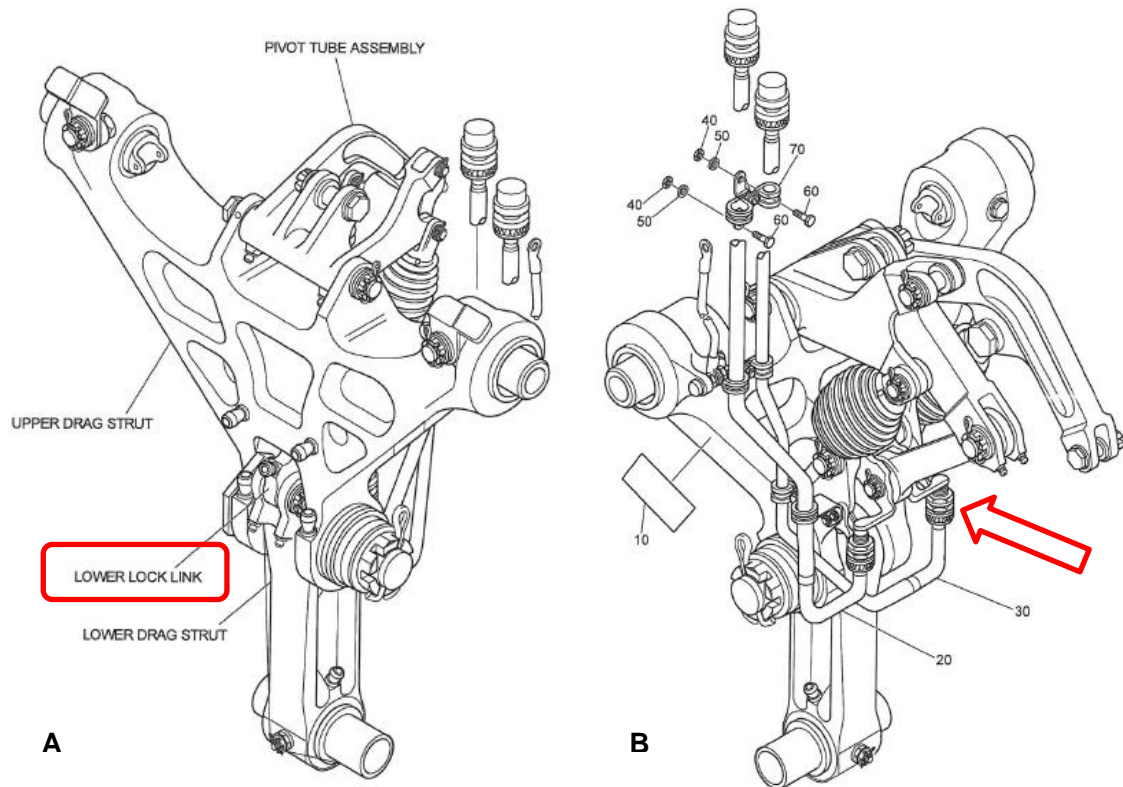
Fig.5. Drag Strut Assembly: A – front view (red frame shows the name of the component which was damaged during the accident); B – rear view (red frame shows the name of the component which was damaged during the accident). [source: CMM 32-21-03]

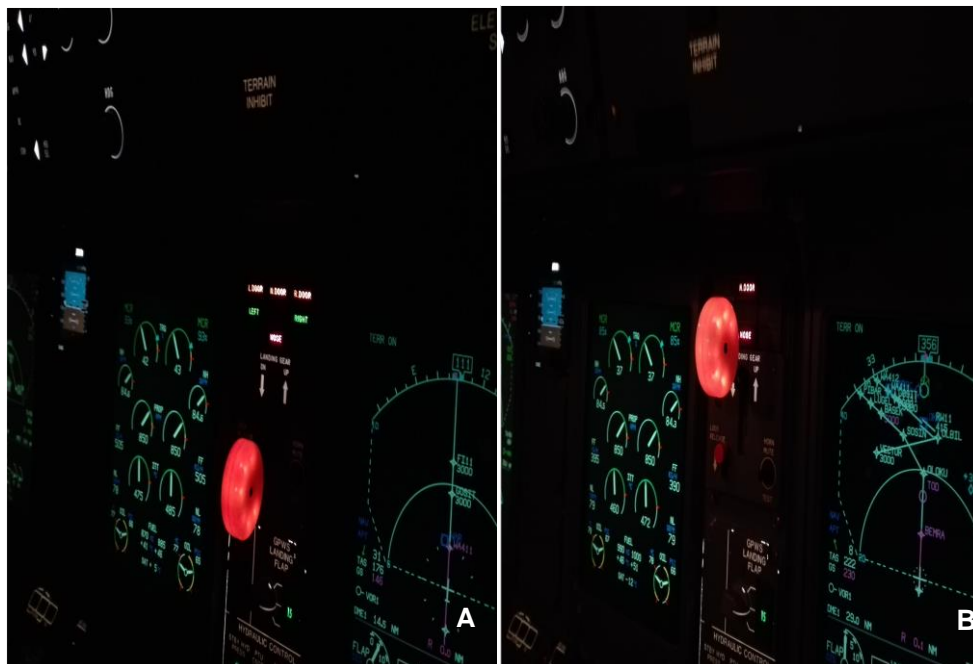
Fig. 9. Landing gear control panel: A – Landing Gear Selector Lever DOWN;
B - Landing Gear Selector Lever UP [source: FO]

In the investigated accident the NLG was not locked in the retracted position and the NLG doors remained open (Fig. 9, therefore the description of the retraction process has been also ceased at this stage. Then the landing gear was extended with the alternate system, therefore, in the next chapter the operation of the alternate landing gear extension system is presented.

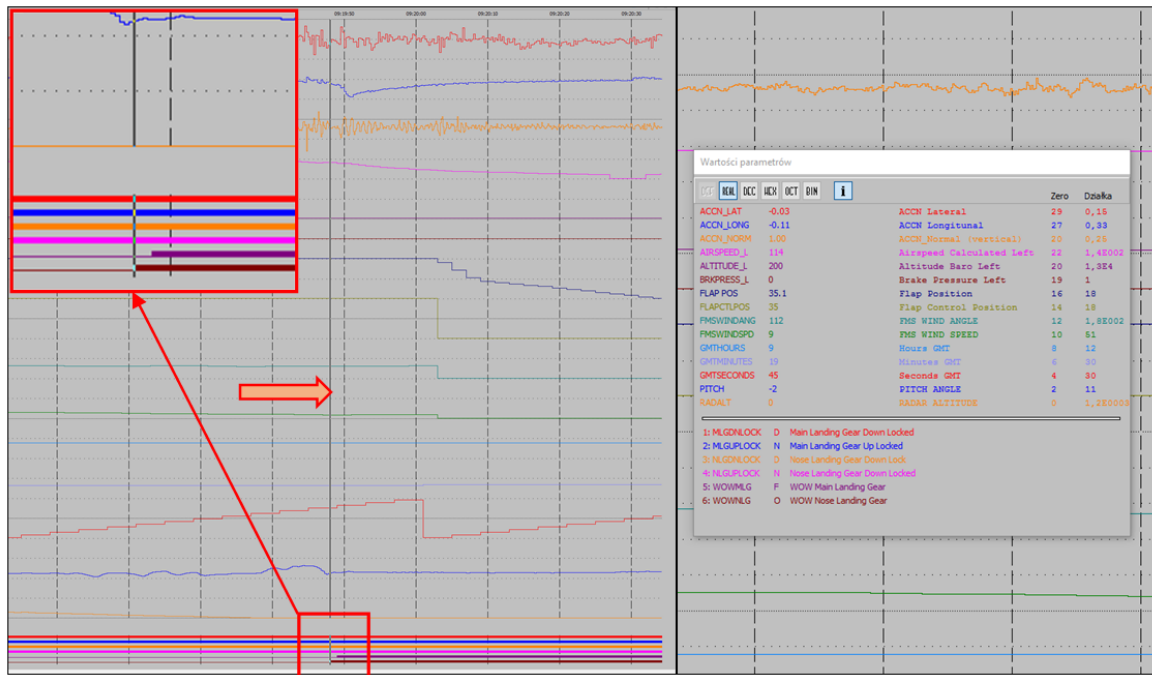
Fig. 22. Flight parameters from the landing of the SP-EQG on 10 January, 2018 at 9:19 hrs UTC. The arrow in the graphic on the left shows the moment when the NLG sensor recorded weight (horizontal brown line at the bottom); the moment when MLG sensors recorded weight is shown by the purple line (second from the bottom). The values of selected parameters at the time when NLG sensor recorded weight are shown in the table on the right [source: SCAA - FDS 9]

As for SP-EQG, out of 2 854 landings in the analyzed period, 69 cases when the NLG wheels were loaded prior to MLG wheels were found, including one on the day of the accident in the morning hours (Fig. 22 and 23). The common feature for the aforementioned landings, in addition to the sequence of the NLG and MLG loading, was the negative pitch angle.

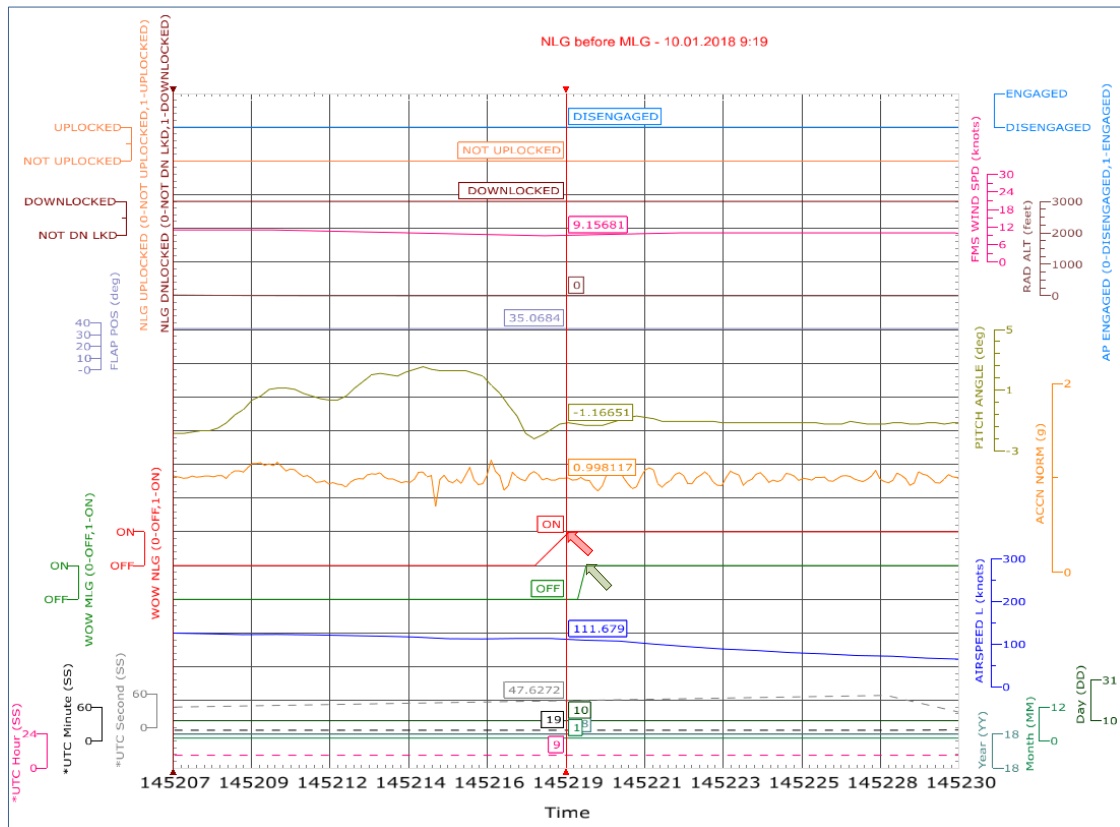
Fig. 23. Flight parameters from the landing of the SP-EQG on 10 January, 2018 at 9:19 hrs UTC. The red arrow in the graphic shows the time of NLG loading, the time of MLG loading is shown by the green arrow [source: PKBWL – Insight 4.9]

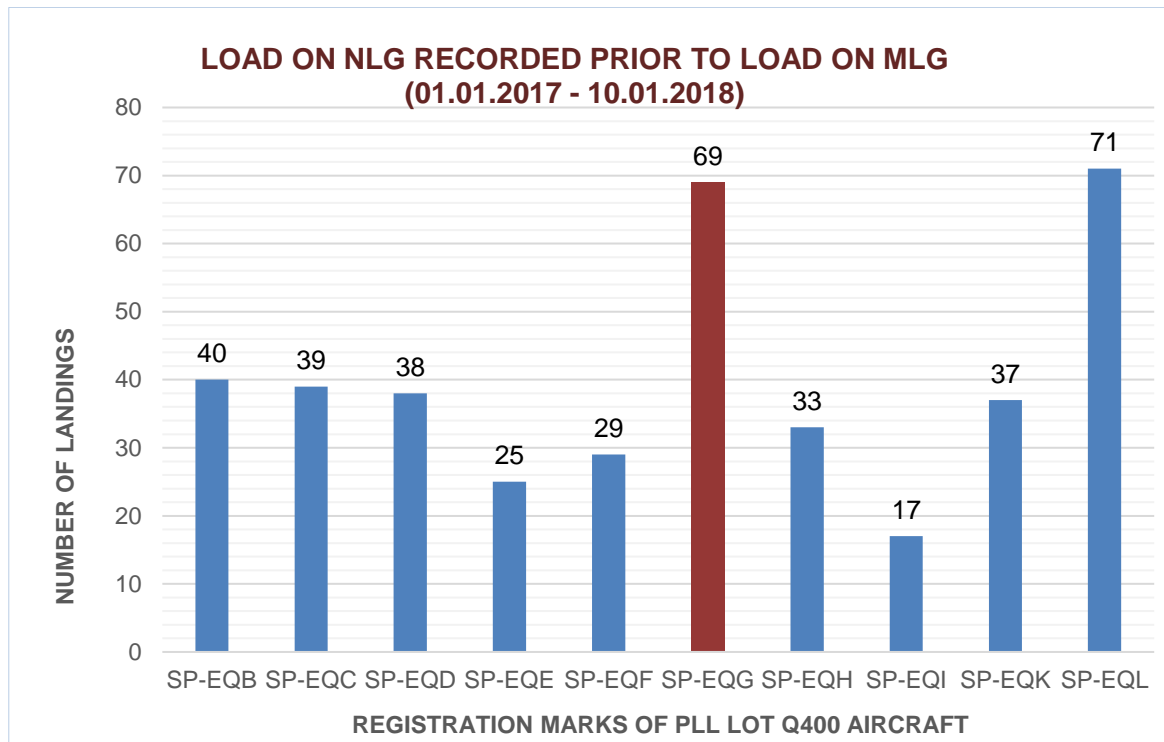
The PKBWL analysis showed that there were 398 landings (on ten Q400 aircraft) which had met the above conditions and that two aircraft were significantly above the average, including SP-EQG (see Fig. 24).

Fig. 24. Number of landings with weight on NLG signaled prior to weight on MLG - SP-EQG airplane is marked in brown

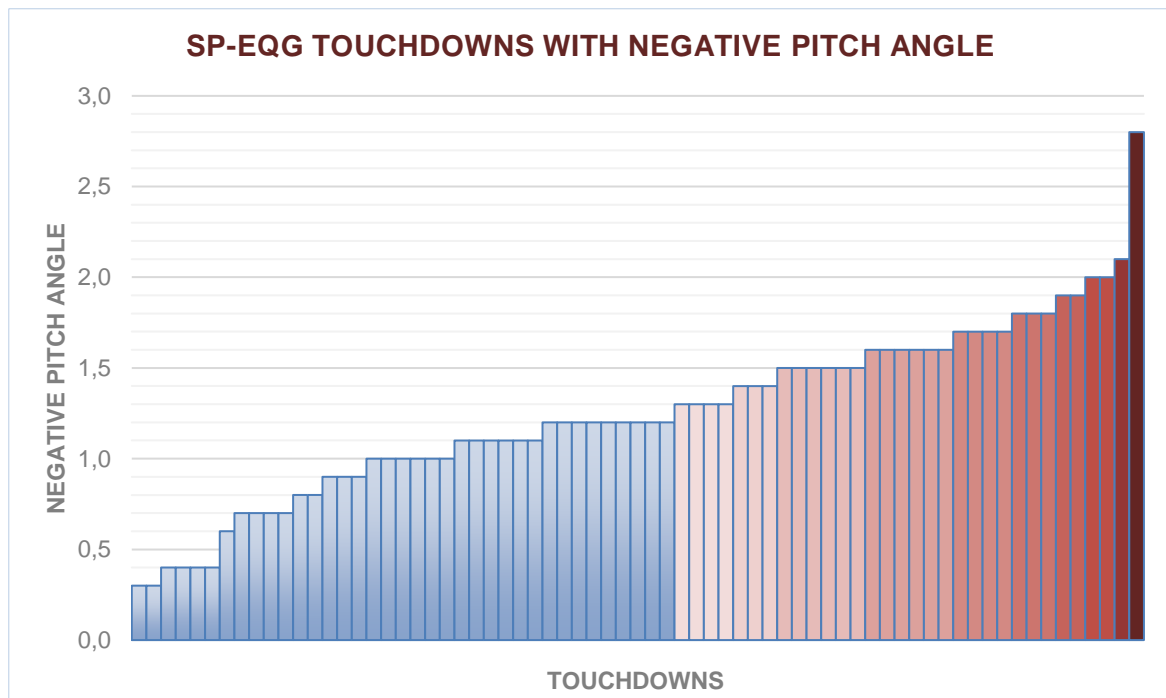
The data also showed that 32 landings of SP-EQG occurred at the negative pitch angle (PA) greater than 1.2° (Fig. 25).

Fig. 25. Presentation of 69 landings of the SP-EQG with a negative pitch angle during the touchdown, when weight on NLG was signaled prior to weight on MLG – shades of burgundy color show touchdowns with a negative pitch angle equal or greater than 1.3° . Note: the chart does not show the landings in the chronological order.

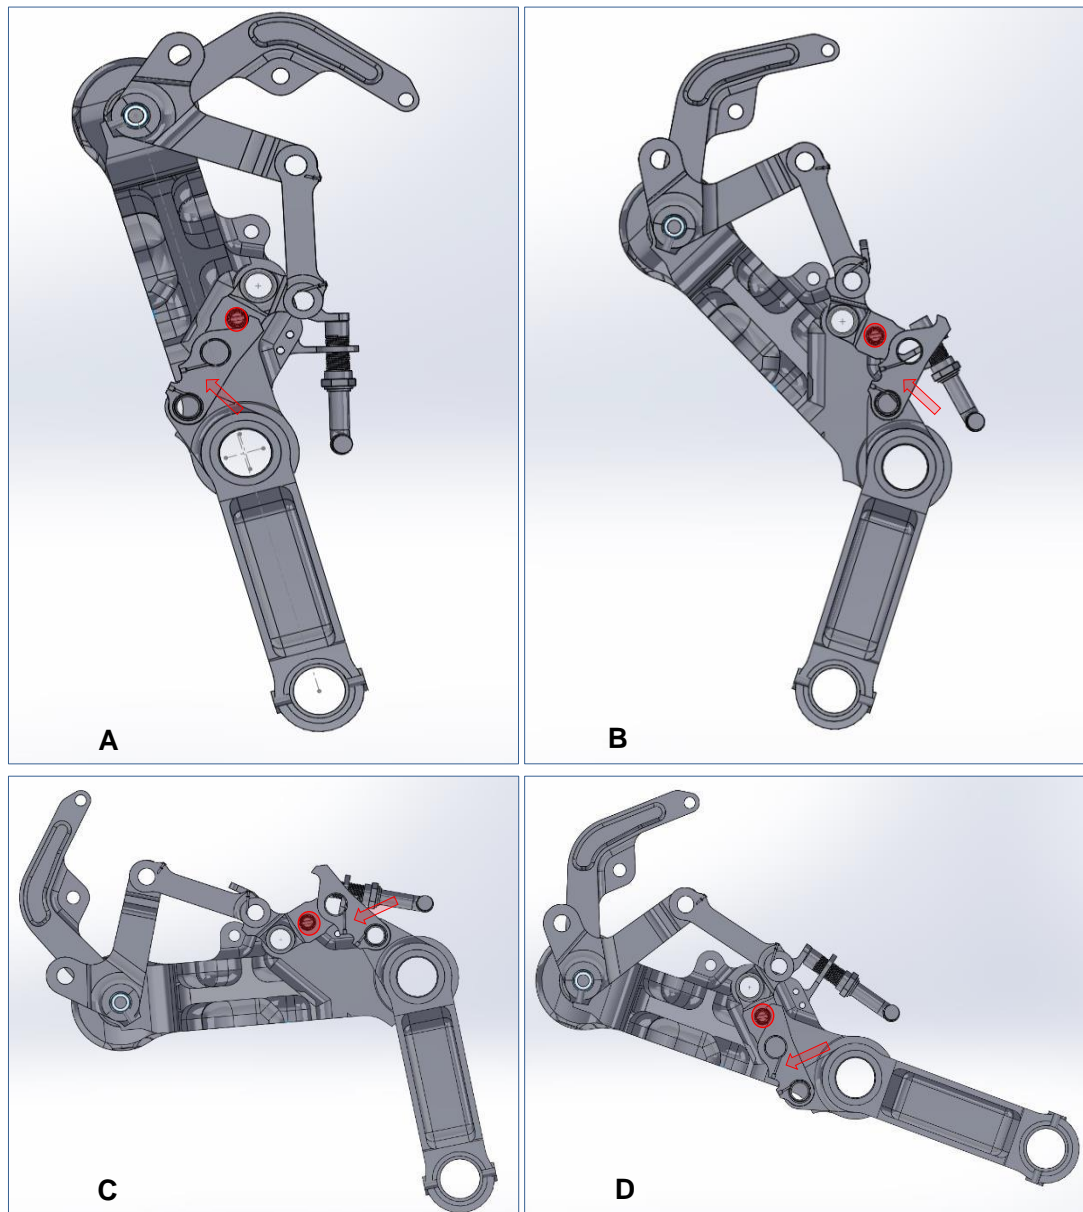
The phases of the correct retraction of the NLG are shown in Fig. 31 A – D. In the initial phase LLL is pulled away from the "Stop Pin" (Fig. 32-A) and the sleeve (Fig. 31-B). LLL contact with the pin sleeve occurs only in the last phase of retraction, which, according to the FDR recording, did not occur.

Fig. 31. NLG DSA model during correct retraction - longitudinal section: A - starting position (landing gear extended, downlocked), B - first phase after unlocking and start of retraction, C - final phase (before retracting and uplocking) , D – retracted and uplocked position. The red arrow shows LLL and the circle shows Stop Pin

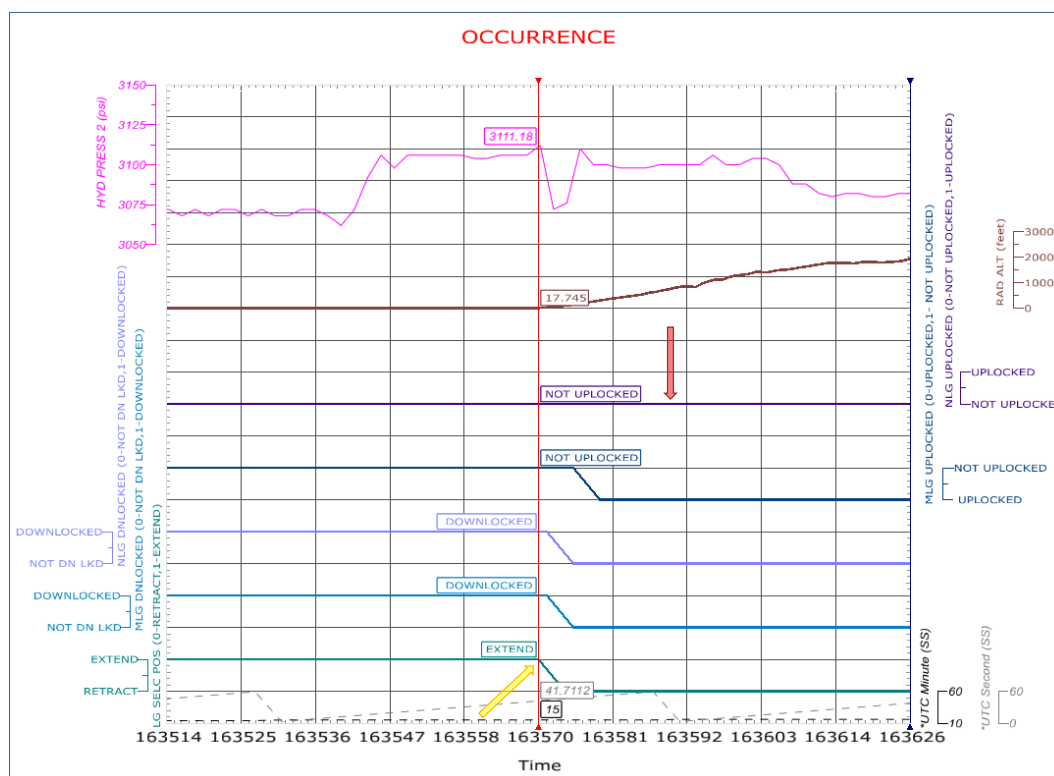
Fig. 35. Pressure change in No. 2 hydraulic system during retraction of the SP-EQG landing gear after the take-off from EPKK on 10 Jan 2018 and the status of NLG and MLG – the yellow arrow shows the moment of selecting the LGSL to the UP position; the red arrow shows the status of NLG – not locked in the retracted position [source : PKBWL – Insight Analysis 4.9]

No significant differences can be seen on the graphs of the pressure change in No. 2 hydraulic system during the normal retraction of the SP-EQG landing gear and retraction during the accident flight.
