# FINAL REPORT

OCCURRENCE NO. – 2022/3285

AIRCRAFT – Cessna TU206G, OK-ROY

DATE AND PLACE OF OCCURRENCE – 24 June 2022, EPBA

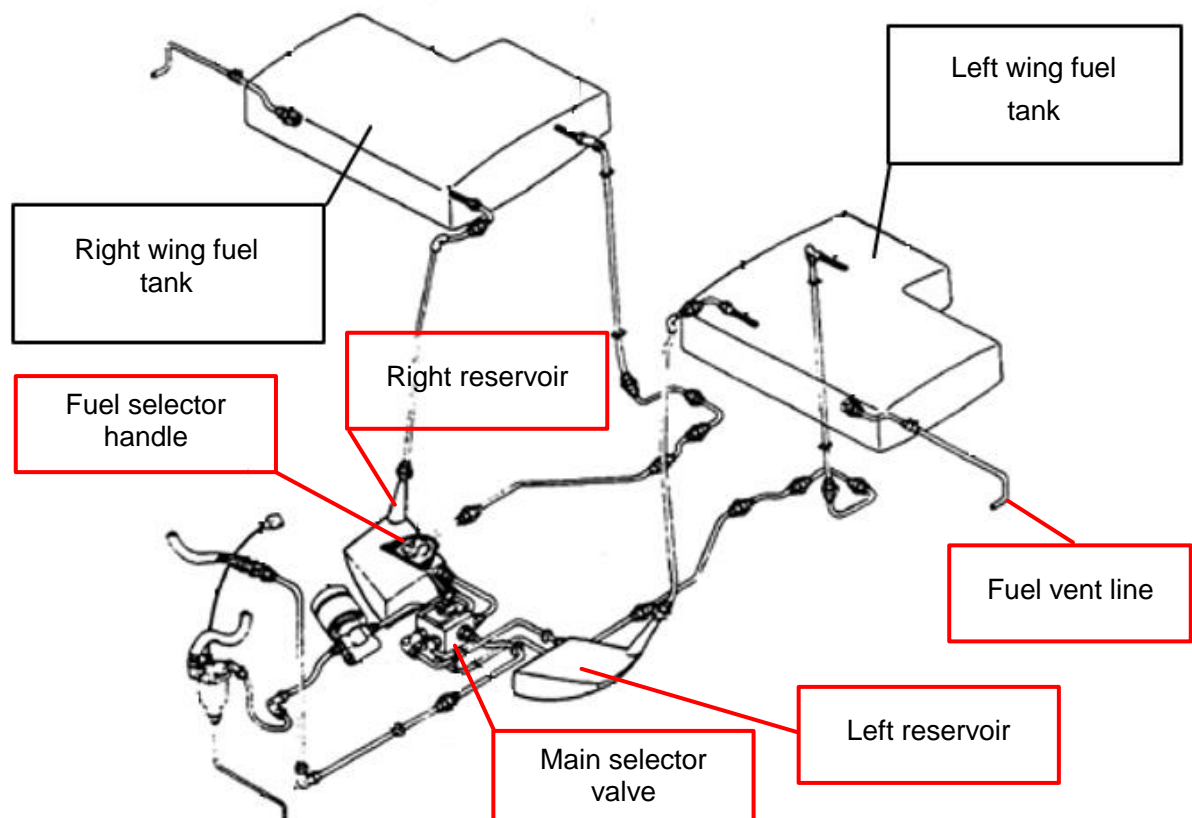
**Fig. 10.** Diagram of the fuel instalation of C206 aircraft [source: AMM]

The drainage systems of both fuel lines were open, and the vents of the tanks were not clogged in any way. The fuel system was not damaged at the time of the incident or during the transport of the wreckage to the hangar. The diagram of the fuel installation is shown in Fig. 10.

To check whether the valve of the fuel line of the right wing was not hanged in the "Open" position (as requested by the aircraft operator), the following test was made: with the tank in the left wing emptied, the empty tank in the right wing was refueled. With the fuel valve closed (off position), the fuel did not flow. However, the flow appeared each time the valve was opened to the "right tank" position and disappeared immediately after its closure. The valve worked properly.
