State Commission on Aircraft Accidents Investigation

# FINAL REPORT

2024-0057

**Salt Aviation Sp. z o. o.  
Robinson Helicopter Company R44 Cadet SP-NHM**

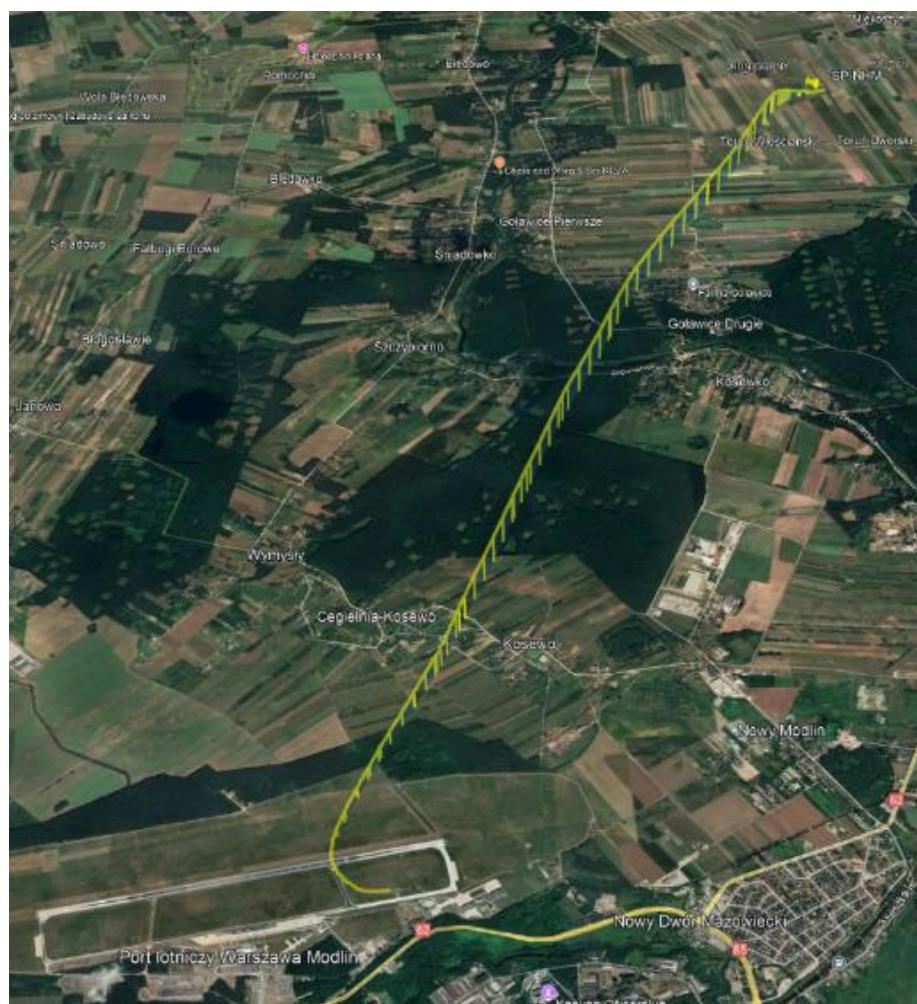
Fig. 2. Flight path based on data from SkyDemon software plotted on Google Earth map, 52°31'31" N 020°43'26" E, elevation 314 ft.

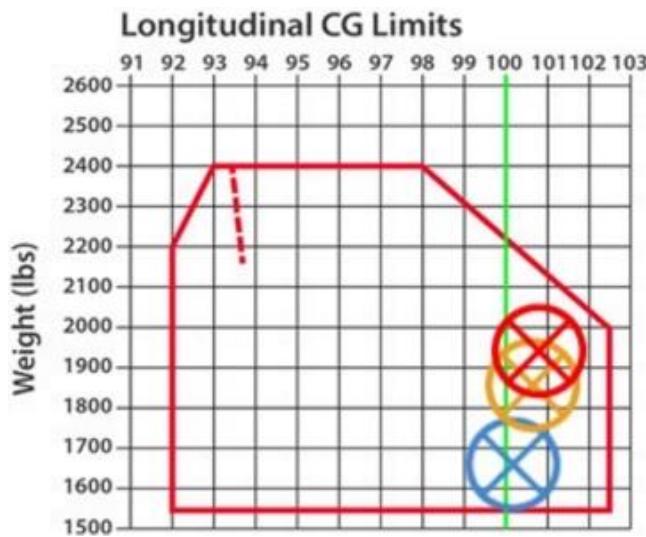
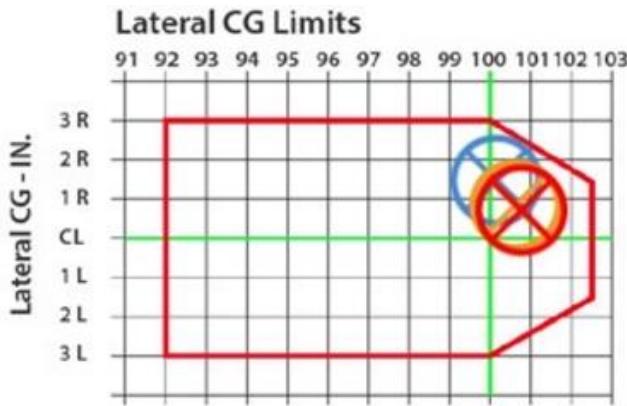
Fig. 4. Location of the center of gravity on the longitudinal axis (red marker – take-off weight, blue marker – helicopter weight without fuel, yellow marker – landing weight for the planned flight).

Figure 5. Position of the centre of gravity in the transverse axis.

The centre of gravity was in the correct position throughout the flight. The maximum take-off weight was not exceeded (Figures 4 and 5).

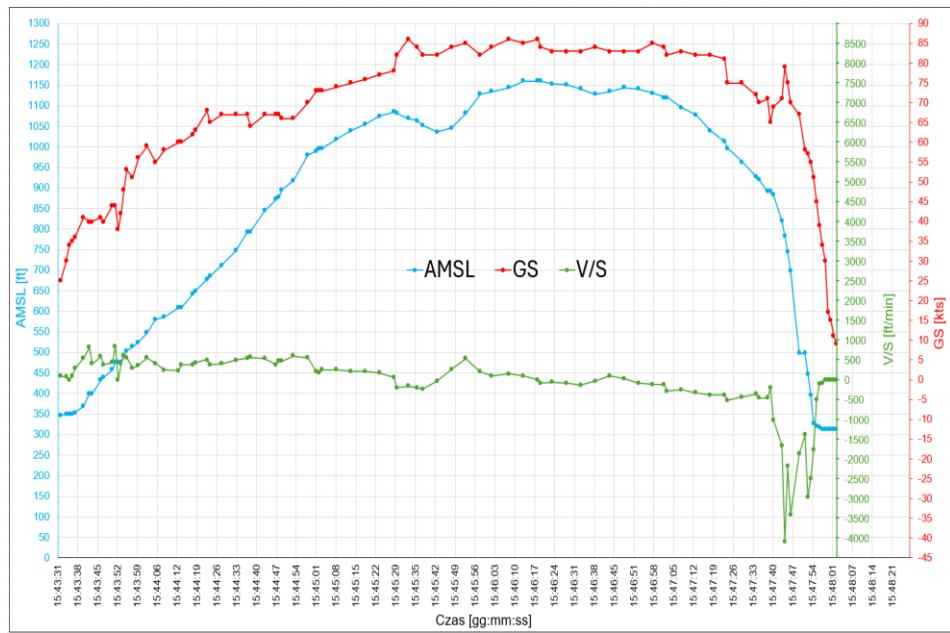
PKBWL downloaded the flight record of the incident from the pilot's phone. After converting and recalculating the data, the following flight parameters were obtained (Fig. 8):

Fig. 8. Record of flight altitude (AMSL), speed (GS) and vertical speed (V/S) read from SkyDemon software.

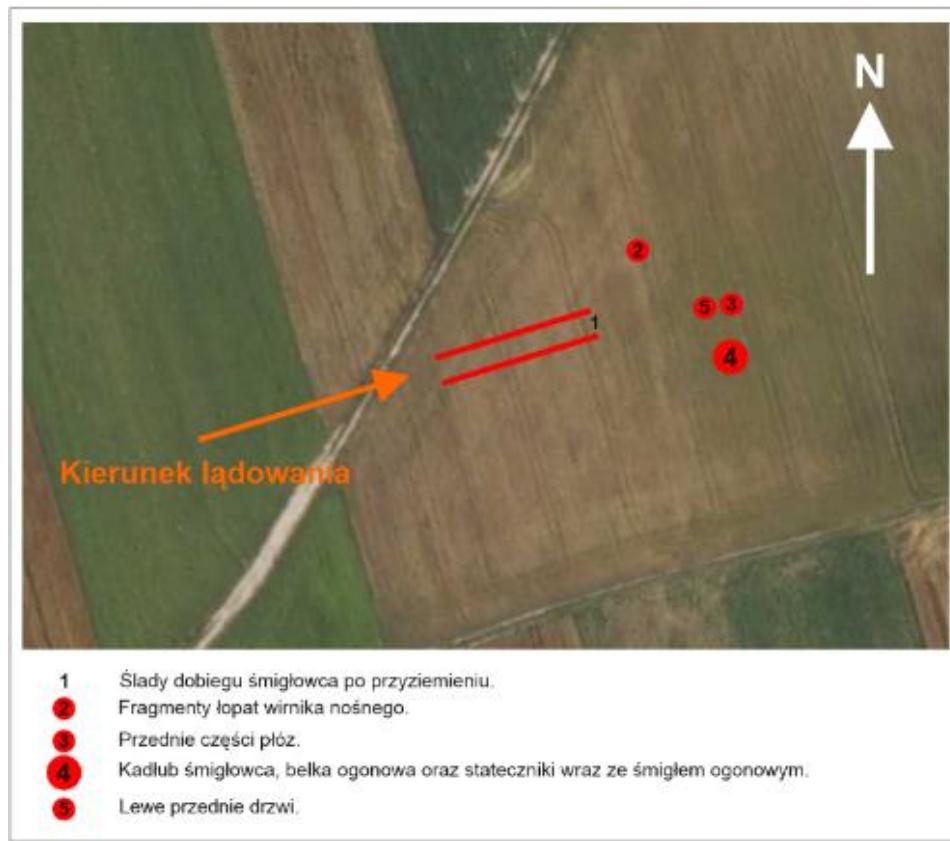
Touchdown occurred at a speed of approximately 35 kt.

Fig. 10. Sketch of the crash site.
